### Structure Type Studies

Re: Great Parks of Hamilton County – Oasis Corridor  
B&N Bridge Assessment – Collins Ave

April 2, 2026

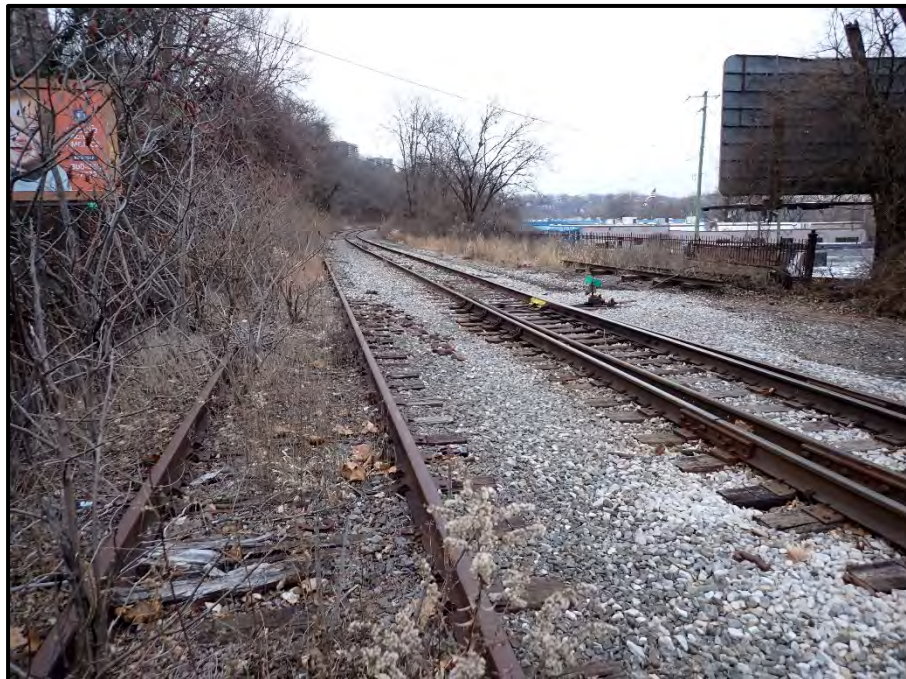
**Photo 4** – Looking east at the typical top of rail condition. Note: checking and some splitting throughout rail road ties.

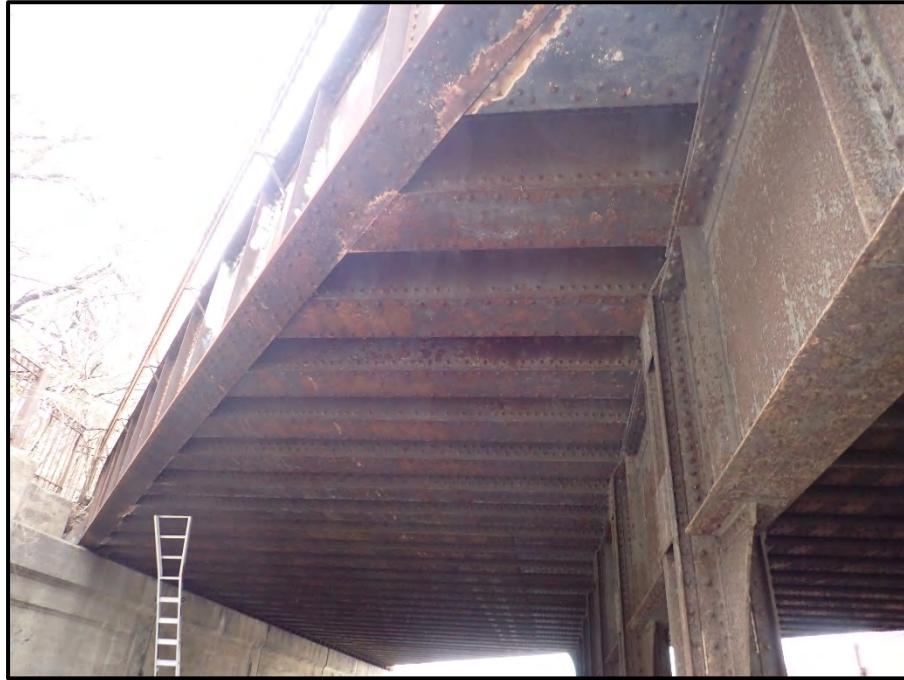
**Photo 5** – Looking north at the underside of span 1. Note: moderate surface rust throughout with isolated locations of section loss.

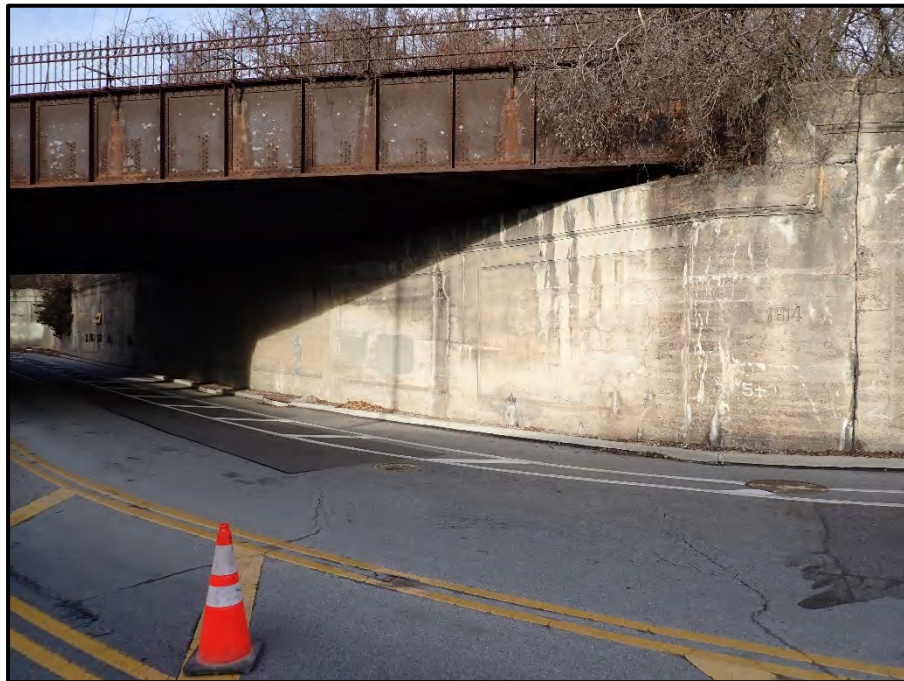
Both abutments exhibit water staining and multiple isolated moderate width vertical and horizontal cracks (**photo 6**). The concrete crash barrier exhibits isolated major spalls at the top of the barrier (**photo 7**). Exposed portions of the steel pier columns exhibit extensive section loss to the vertical angles and batten plates (**photos 8 & 9**) (rehabilitations for these deficiencies are included in the prior mentioned plan set developed for SORTA).

**Photo 6** – Looking northeast at the west abutment elevation. Note: some minor to moderate width cracks to the abutment wall. Cracking is heaviest in the cap directly under the bearing seat.

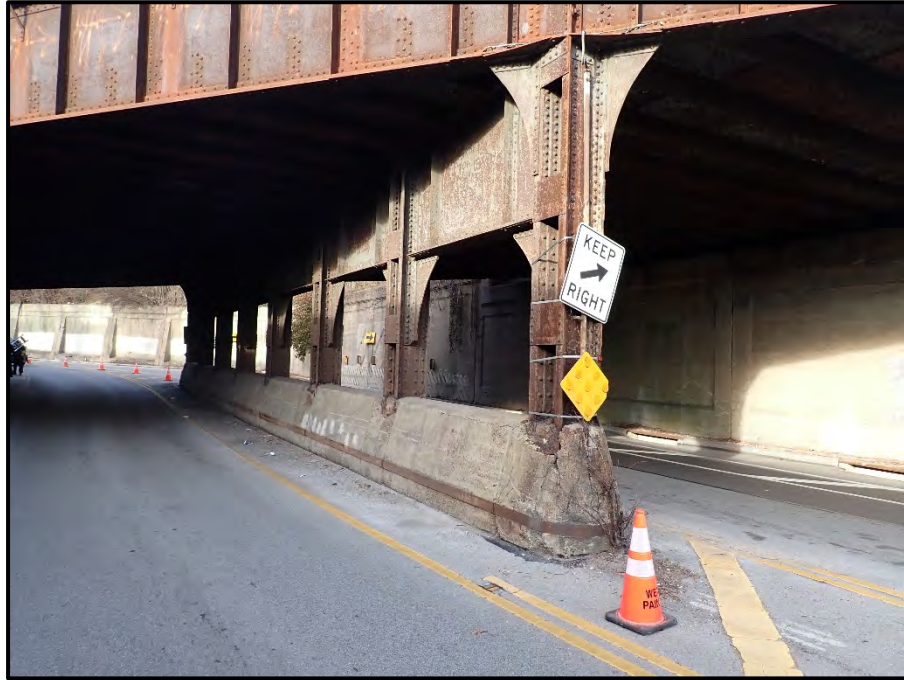
**Photo 7** – Looking northeast at the west face of pier 1. Note: spalling around the base of the pier columns. Concrete repairs at the base of the columns is included in the repair plans.

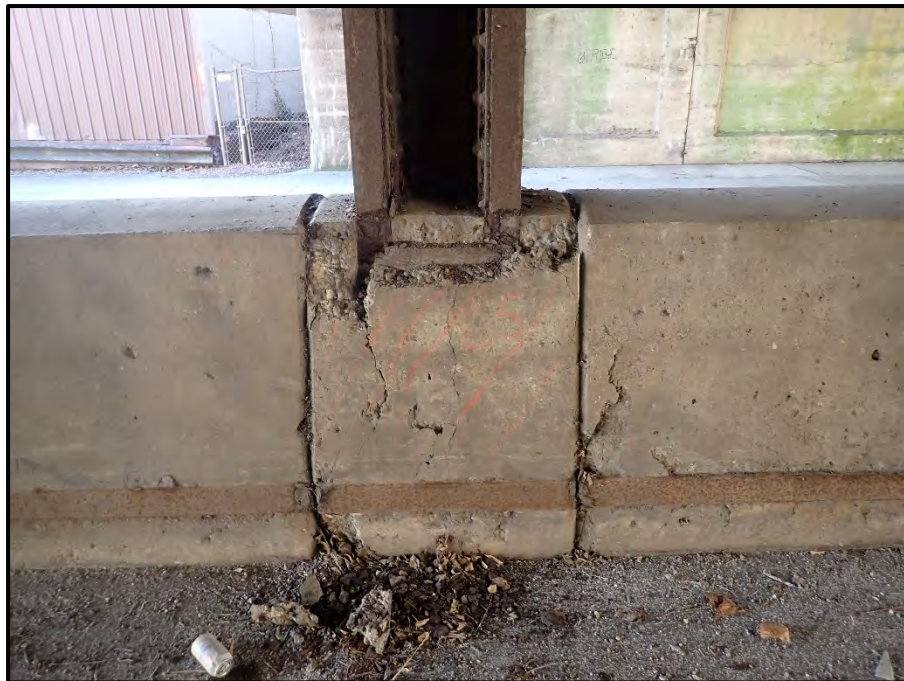
**Photo 8** – Looking west at an overall of the east face vertical angle legs at the pier wall exhibit up to 75% section loss to angle legs over a 1" tall x full width area.

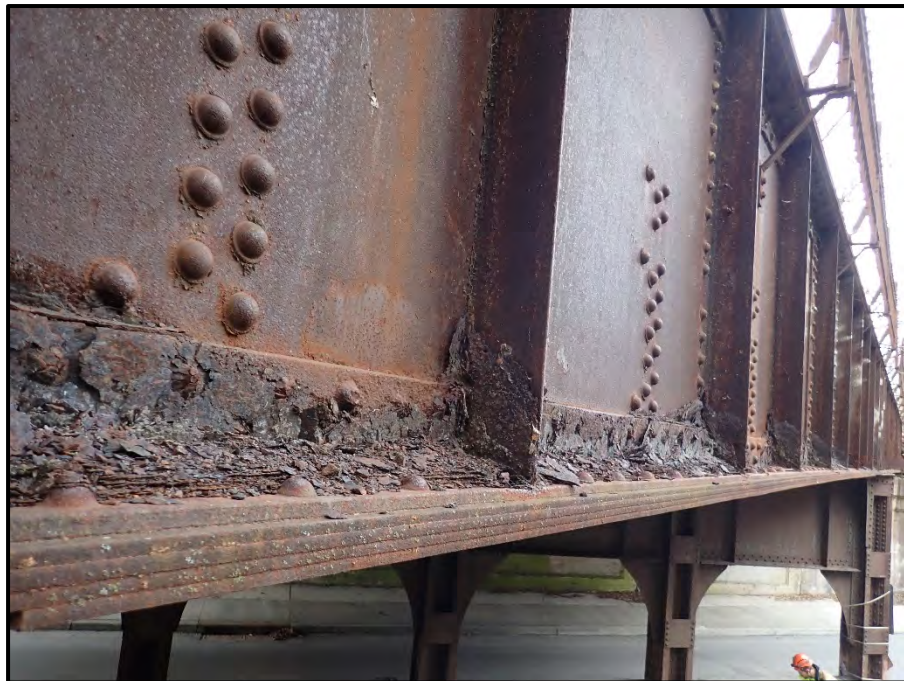
**Photo 10** – Looking southwest at girder 1, east end. Note: heavy laminating corrosion and corrosion holes through bottom of outboard vertical stiffeners. First 3 stiffeners from end exhibit corrosion holes up to 5" tall, full width.

| <b>Photo</b> | <b>Call Out #</b> | <b>Comment</b> |
|---|---|---|
| BJP1-13 | 1-BJP-I | Girder 1, east end. Note: heavy laminating corrosion and corrosion holes through bottom of outboard vertical stiffeners. First 3 stiffeners from end exhibit corrosion holes up to 5" tall, full width. |

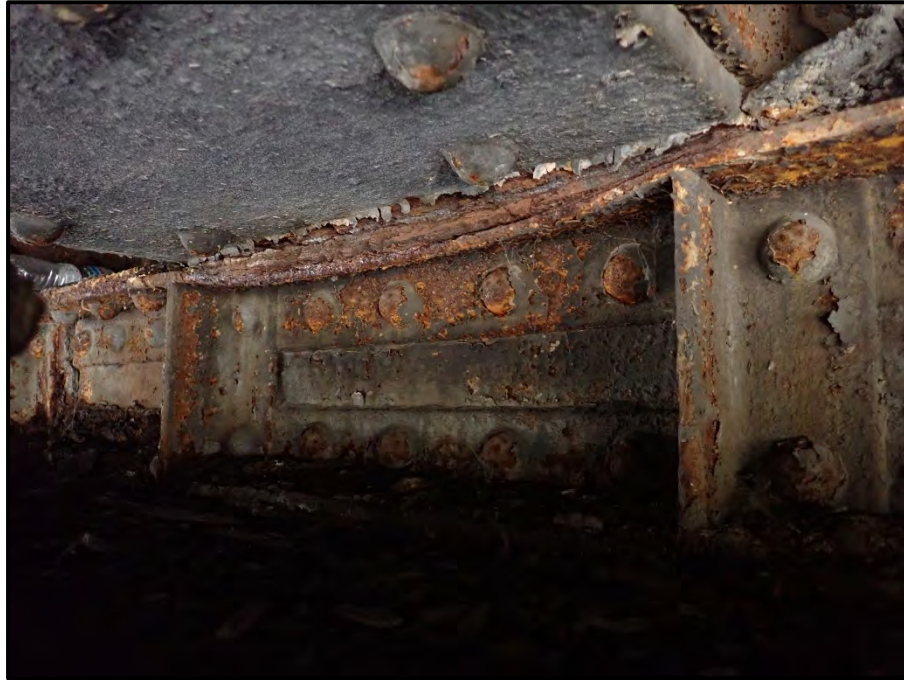
Bridge girders and beams have surface corrosion throughout. Multiple corrosion holes exist in the web and bearing stiffeners at all four corners (**photo 12**) (rehabilitations for these deficiencies are included in the prior mentioned plan set developed for SORTA). Corrosion is heaviest on the exterior girders bottom flanges and in the bottom of webs near the abutments (**photo 10**). Strap/splice plate on the top flange of both girders over the pier exhibit a full width crack (**photo 14**) (rehabilitations for these deficiencies are included in the prior mentioned plan set developed for SORTA). Bearing seats exhibit pack rust between the top of the bearing seat and the underside of the girders (**photo 11**).

**Photo 11** – Looking west at west abutment steel bearing seat under floor beam 15. Note: pack rust up to 1" thick causing deformation to bottom flange

| <b>Photo</b> | <b>Call Out #</b> | <b>Comment</b> |
|---|---|---|
| BJP1-7 | 1-BJP-F | West abutment steel bearing seat under floor beam 15. Note: pack rust up to 1" thick causing deformation to bottom flange. |

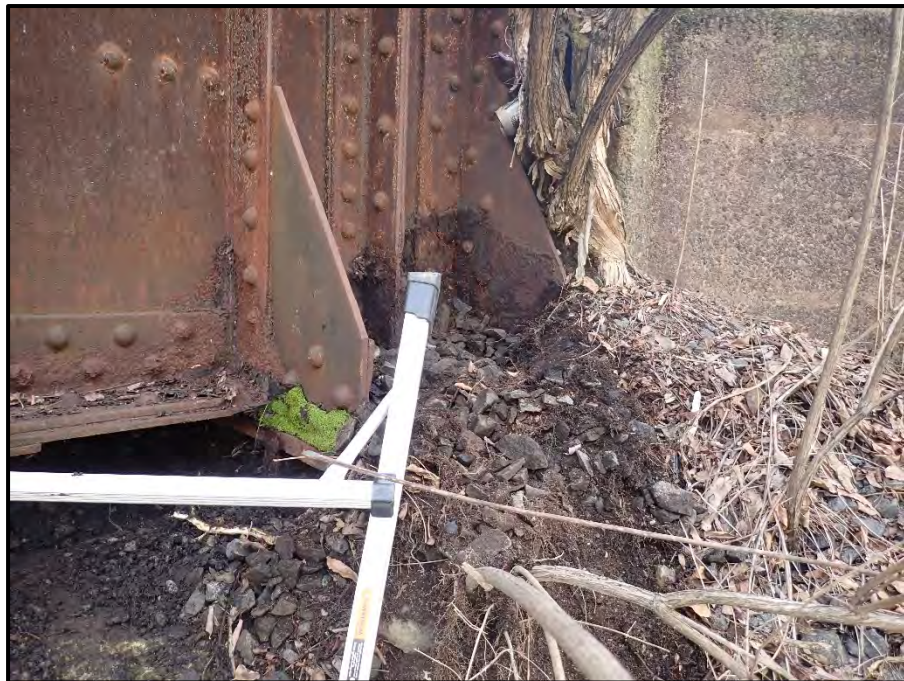
**Photo 12** – Looking southwest at girder 1 at the west abutment. Note: heavy soil and debris accumulation. Active pitting, 1/16" average, to girder web and bearing stiffeners.

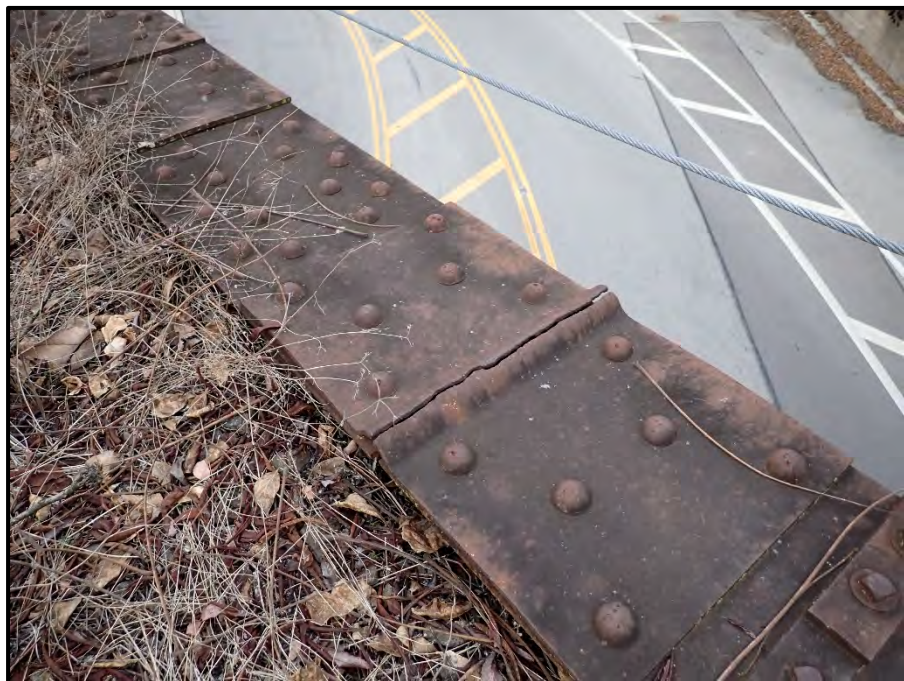
**Photo 14** – Looking northwest at top flange strap/splice plate at midspan of girder 1. Note: full width crack in plate. Similar at same location, girder 2. Appears intentional.

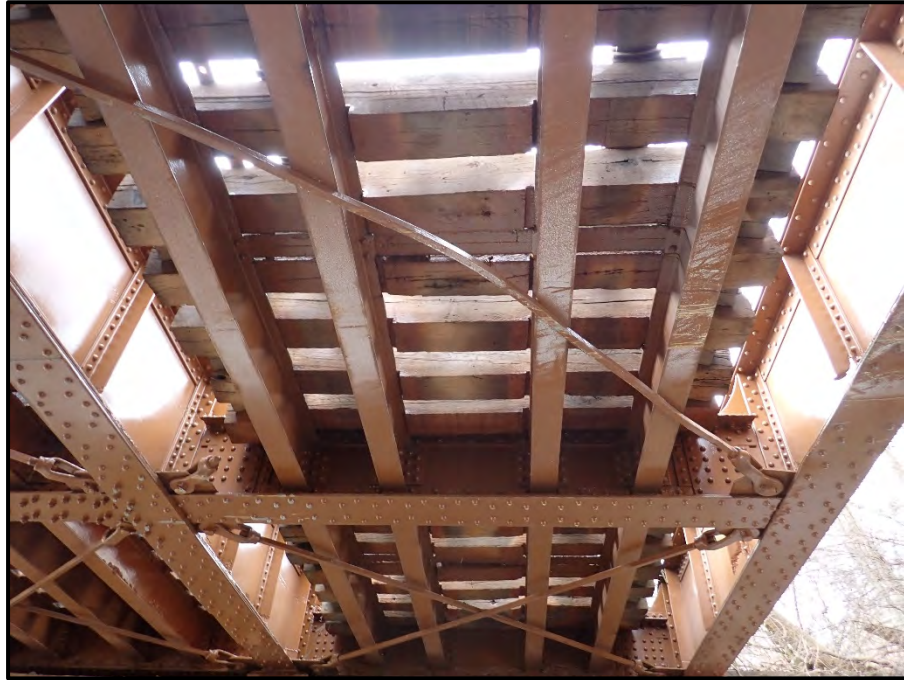
**Photo 5** – Looking west at the typical underside between girders 1 and 2. Note: one missing and one bent lower lateral bracing bar.

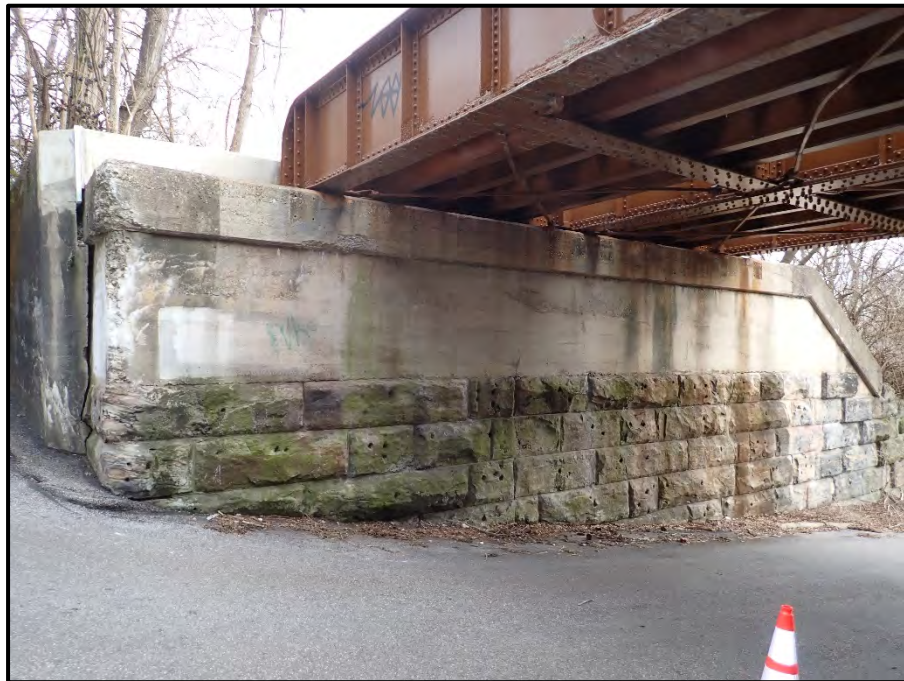
**Photo 6** – Looking southeast at the east abutment. Note: moderate abrasion on the north end of the east abutment. Multiple moderate width horizontal cracks in the north end with minor efflorescence.

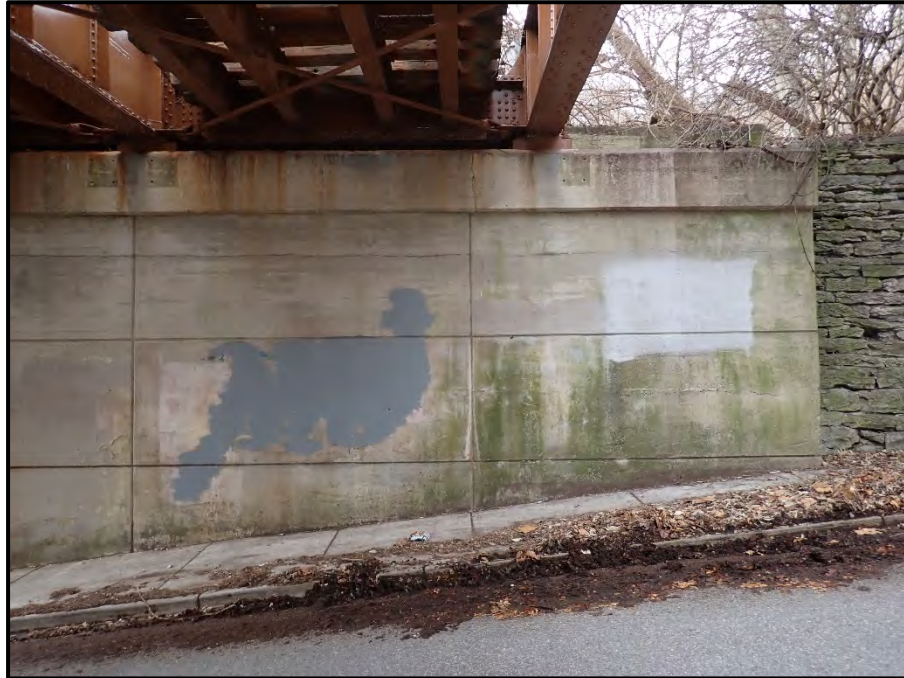
**Photo 7** – Looking west at the west abutment. Note: minor algae growth on the bottom half of the abutment wall under girder 1.

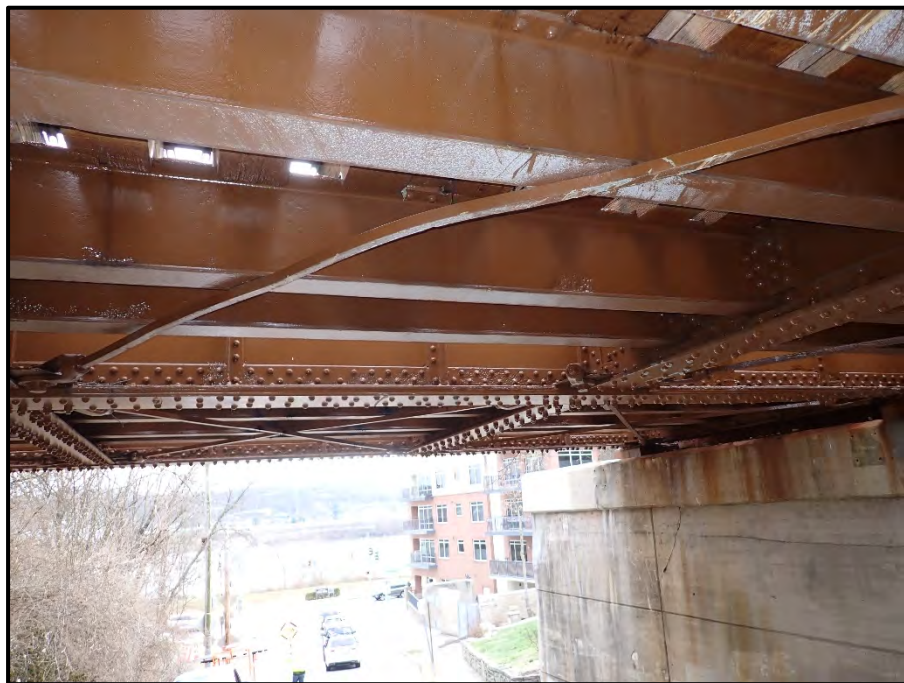
**Photo 8** – Looking south at the missing lower lateral bracing bar in bays 1-2.

| Photo # | Call Out # | Comment |
|---|---|---|
| <b>BJP1-37</b> | BJP-G | Missing one lower lateral bracing bar. |

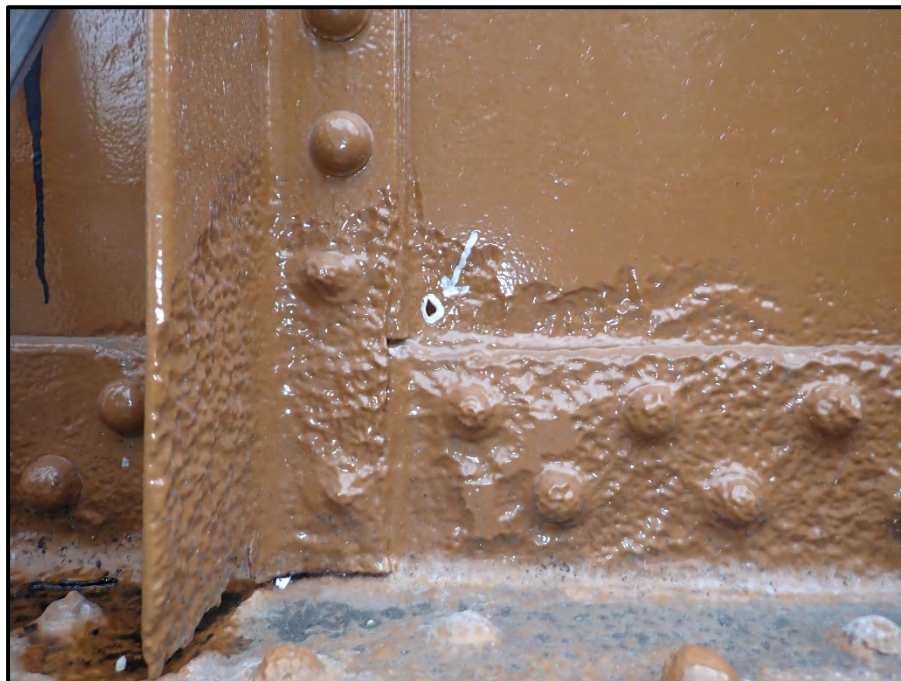
**Photo 11** – Looking south at outboard face of girder 1 at east end between 3rd and 4th stiffeners from east, adjacent to 4th stiffener. Note: 1/2" diameter corrosion hole through web with adjacent 1/8" deep painted over pitting.

| Photo # | Call Out # | Comment |
|---|---|---|
| <b>BJP1-31</b> | BJP-C | 1/2" diameter corrosion hole through web with adjacent 1/8" deep painted over pitting. |

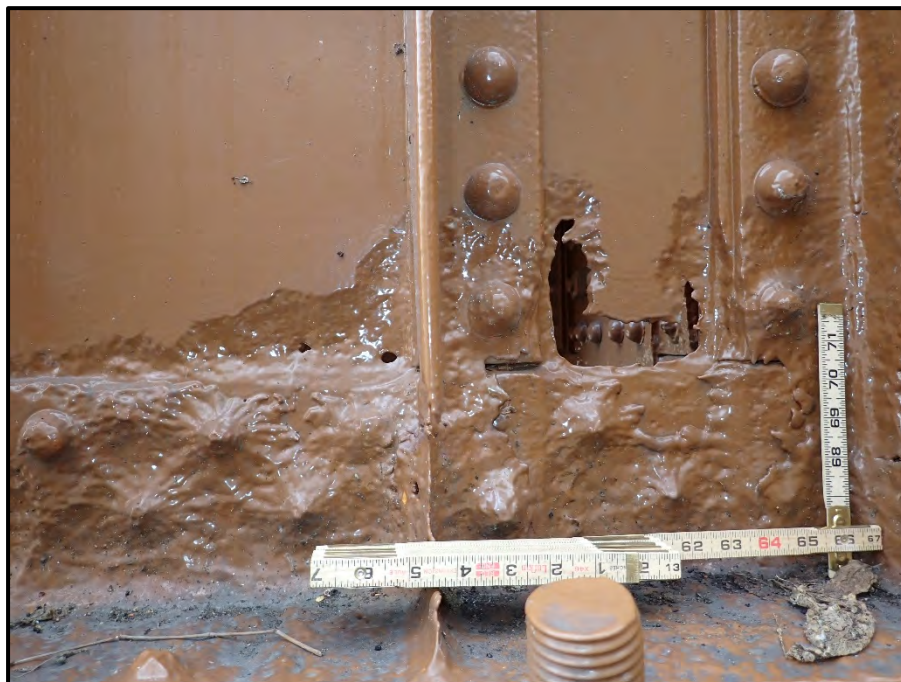
**Photo 12** – Looking south at outboard face of girder 1 at the west abutment. Note: 4" x 4" painted over through hole in web plate between the first and second web stiffener from the end.

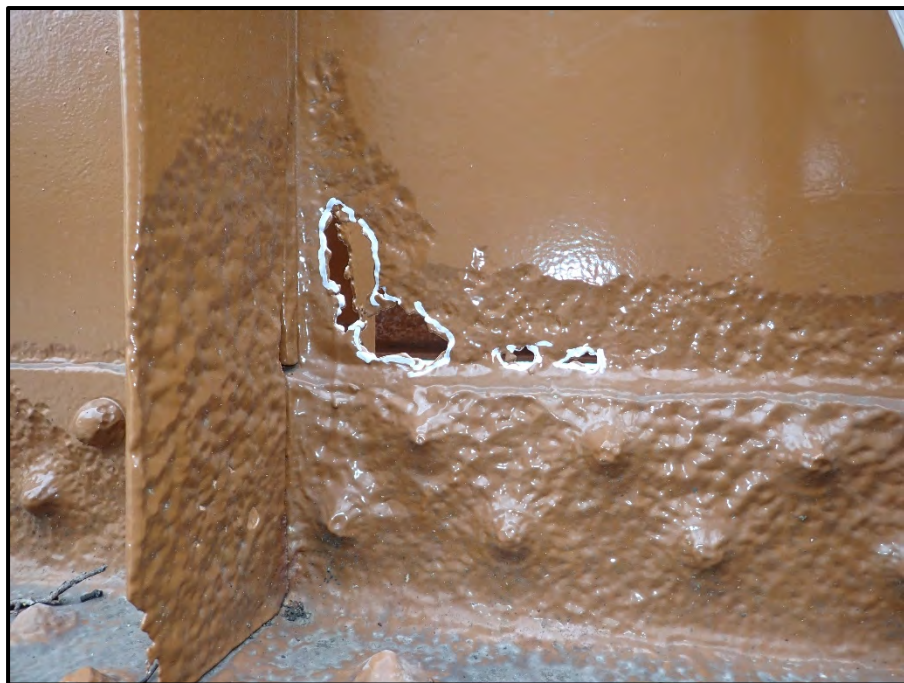
**Photo 14** – Looking south at outboard face of girder 1 adjacent to 4th stiffener from west end. Note: 7" wide x up to 4" tall painted over through hole in web plate adjacent to stiffener.

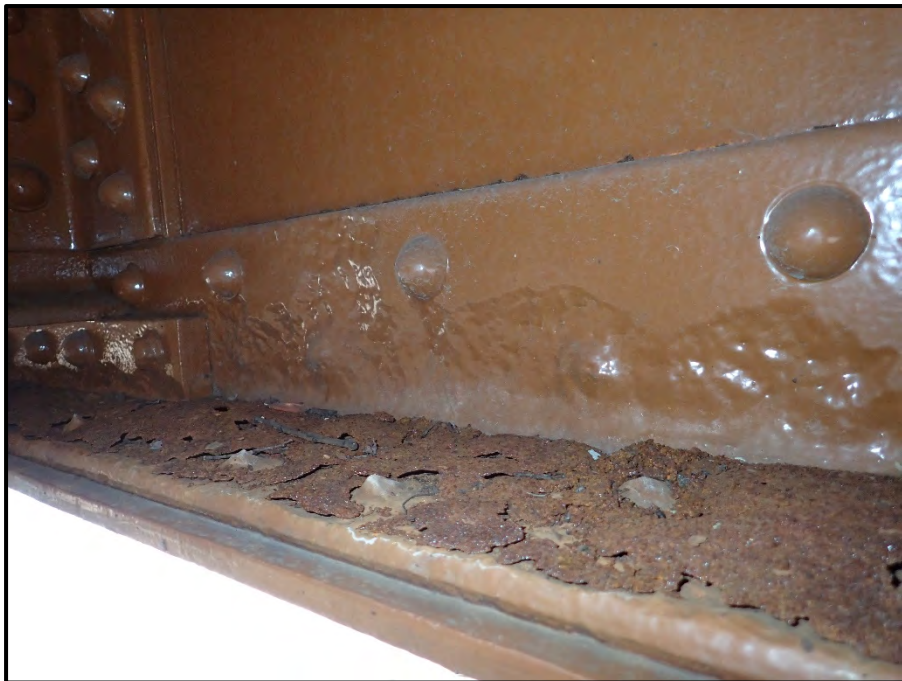
**Photo 20** – Looking southwest at East face of floor beam 2 between stringers 2 and 3. Note: Typical 1/16" deep painted over pitting along bottom 4" of web and bottom flange angles.

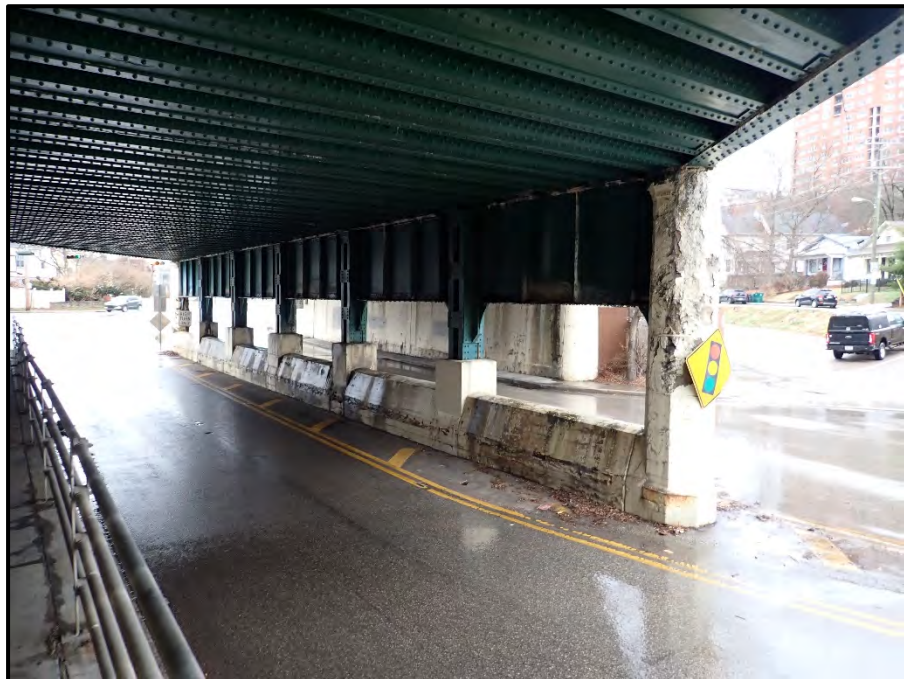
**Photo 6** – Looking northwest at the east face of the pier. Note: heavy spalling on column 7 and along the concrete pier protection.

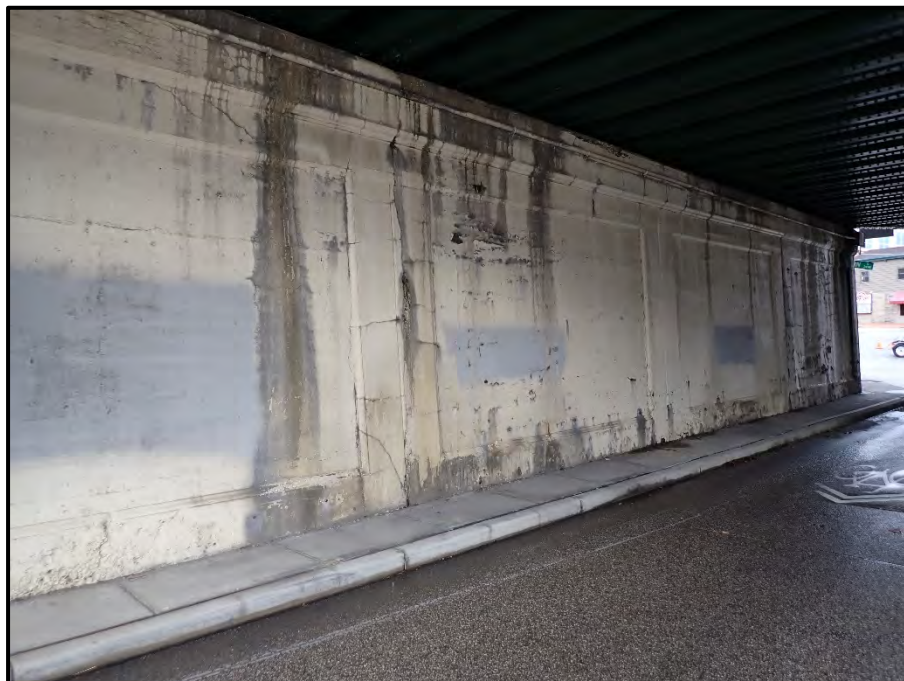
**Photo 8** – Looking northwest overall elevation of the west abutment exhibits vertical and horizontal moderate width cracks in cap. Cracking is heaviest in south half of abutment.

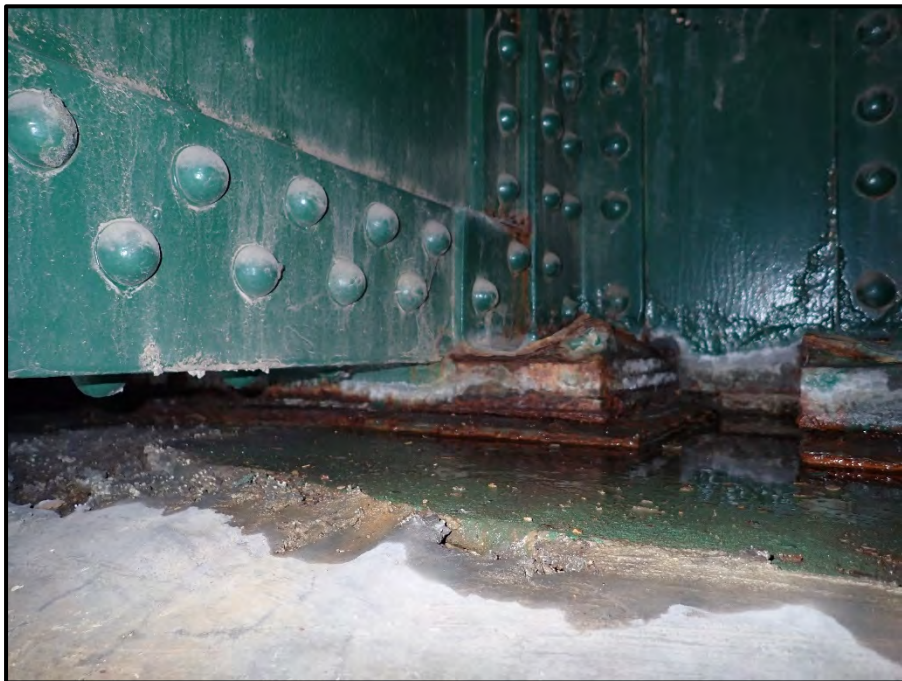
**Photo 10** – Looking west at south face of floorbeam 41 bearing at the west abutment exhibits pack rust peeling the horizontal angle leg with adjacent surface corrosion with negligible section loss.

| <b>Photo #</b> | <b>Call Out #</b> | <b>Comment</b> |
|---|---|---|
| <b>LAL1-31</b> | LAL-F | South face of floorbeam 41 bearing at the west abutment exhibits pack rust peeling the horizontal angle leg. |

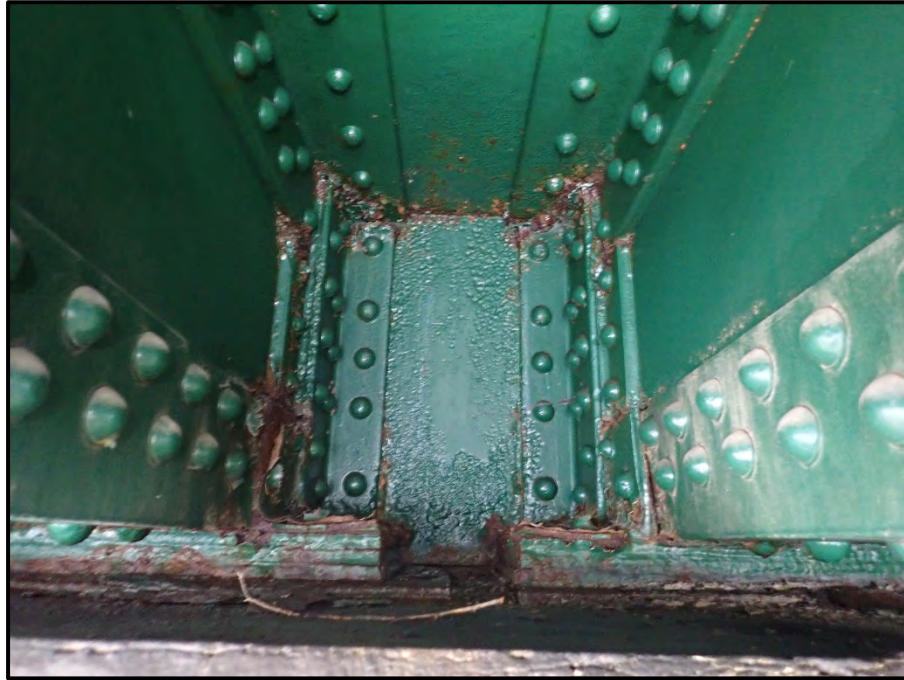
**Photo 11** – Looking south a typical painted over section loss to the steel backwall between beams 7 and 8 at the east abutment. This condition is typical at multiple locations.

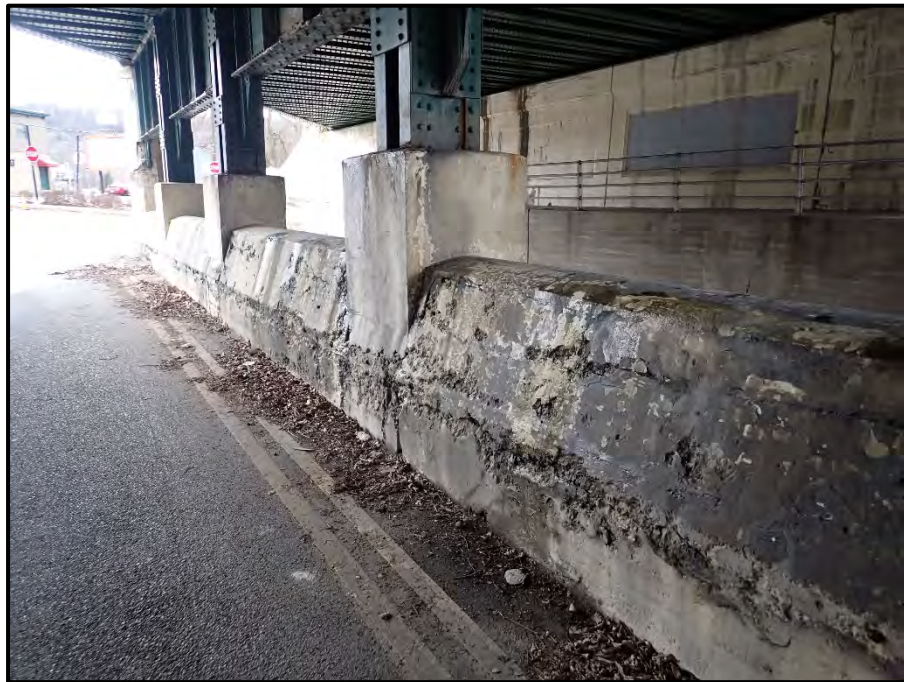
**Photo 12** – Looking northeast at an overall view of the partial height pier wall at column 4. Note: the pier wall exhibits heavy deterioration intermittently, full length. The concrete encasement extensions around base of columns exhibits minor crack, but are generally in good condition.

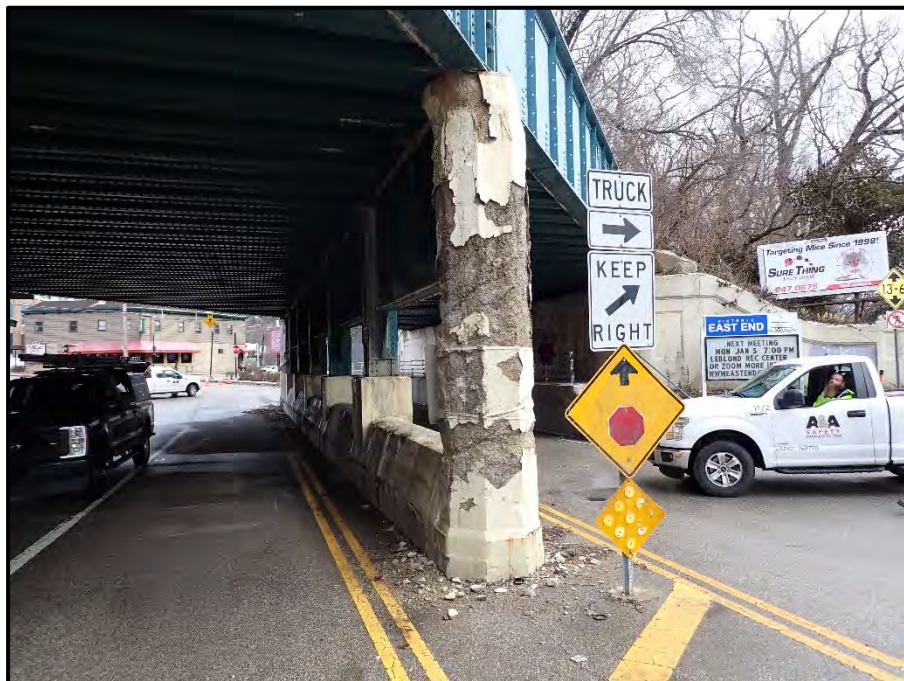
**Pier 1 - Column 7** - concrete is in poor condition and appears to not contain any reinforcement and only appears to protect the underlying built up steel column. A small portion of the steel column is exposed and is in poor condition and exhibit section loss and pack rust between components up to 1/2". Full condition of steel column is unable to be determined due to encasement. Concrete is unsound throughout including portion of exposed core concrete **(photos 13-15)**. Column 1 is in similar condition **(photo 16)**.

**Photo 14** – Looking north at overall of column 7. Note: concrete is in poor condition and appears to not contain any reinforcement and only appears to protect the underlying built up steel column. A small portion of the steel column is exposed and is in poor condition and exhibit section loss and pack rust between components up to 1/2".

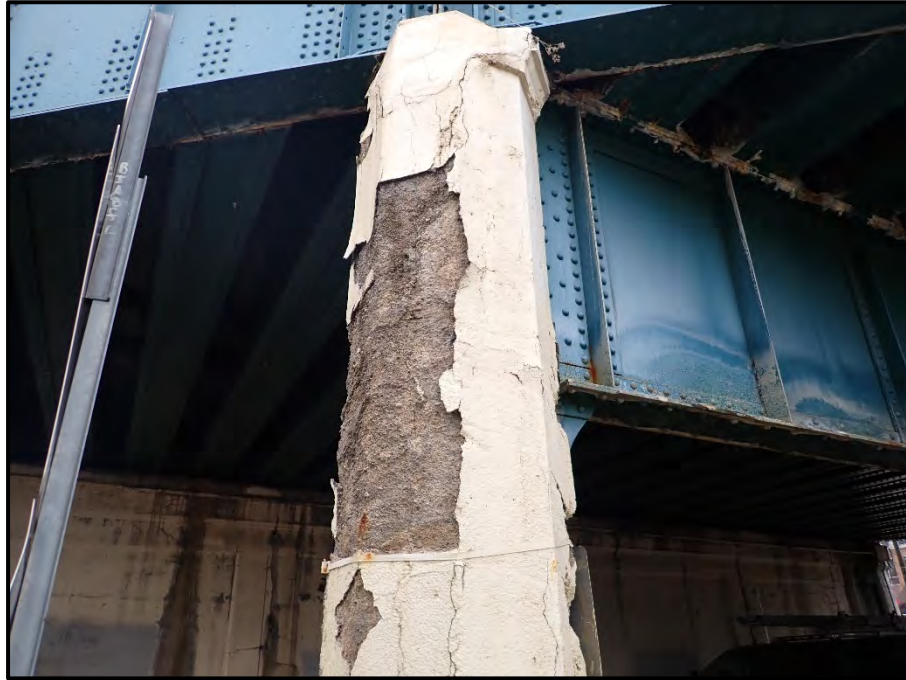
**Photo 15** – Looking west at overall of the top half of column 7. Note: concrete is in poor condition and appears to not contain any reinforcement and only appears to protect the underlying built up steel column.

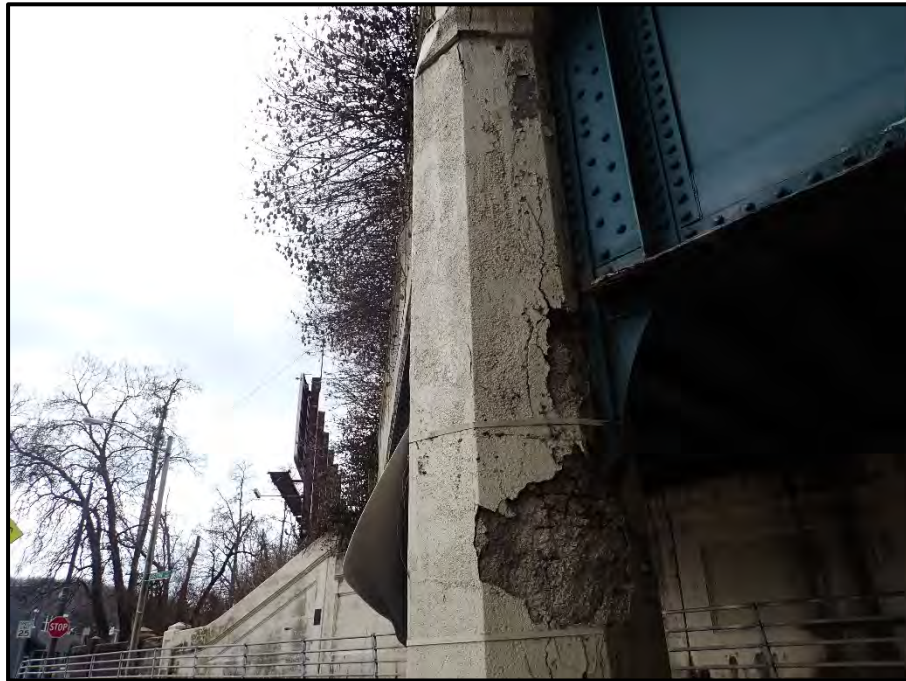
**Photo 16** – Overall, of north column (column 1). Note: column is in similar condition to column 7. Steel frame is not exposed.

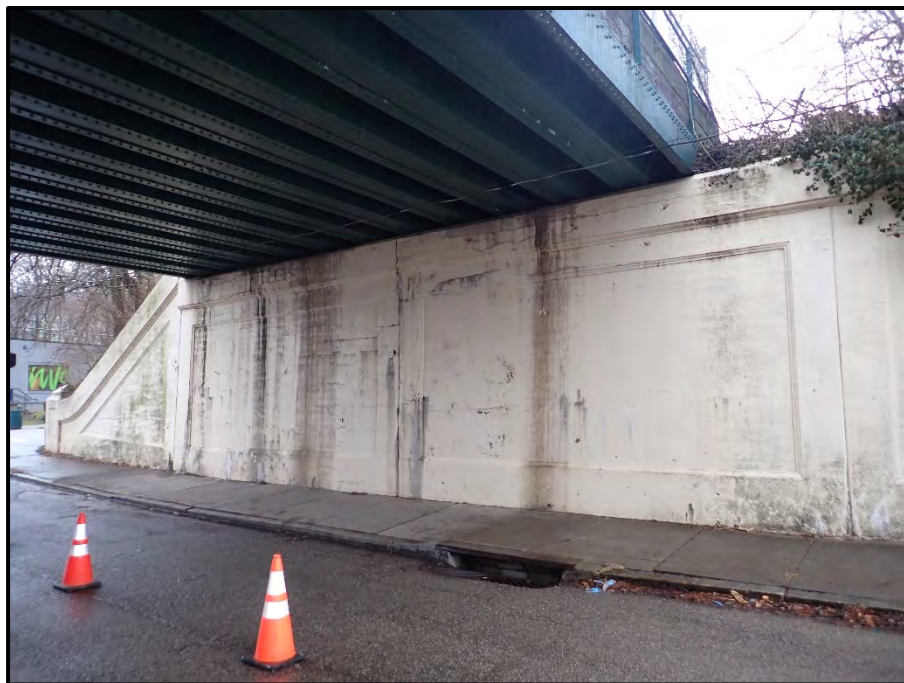
**Photo 6** – Looking northeast at the east abutment elevation.

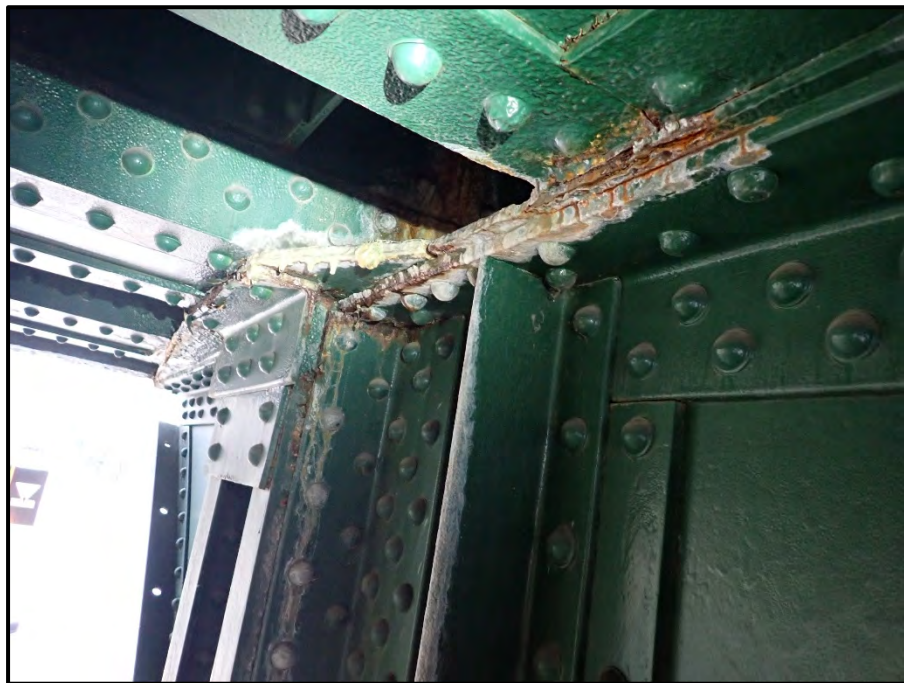
**Photo 8** – Looking south at typical water leakage and moisture staining at pier 1. Note: leakage between beams 10-11 shown. Water leaks through the span 1 to span 2 deck pan interface.

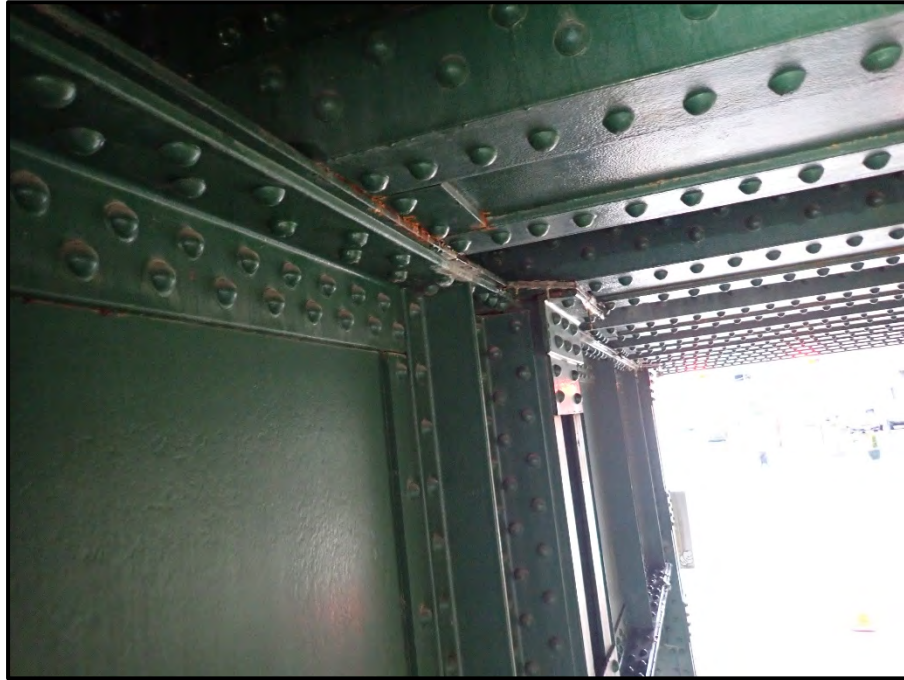
**Photo 9** – Looking north at typical beam to bearing seat condition at pier 1. Photo from beam 9. Leakage is intermittent and heaviest in the end 4 beam bays.

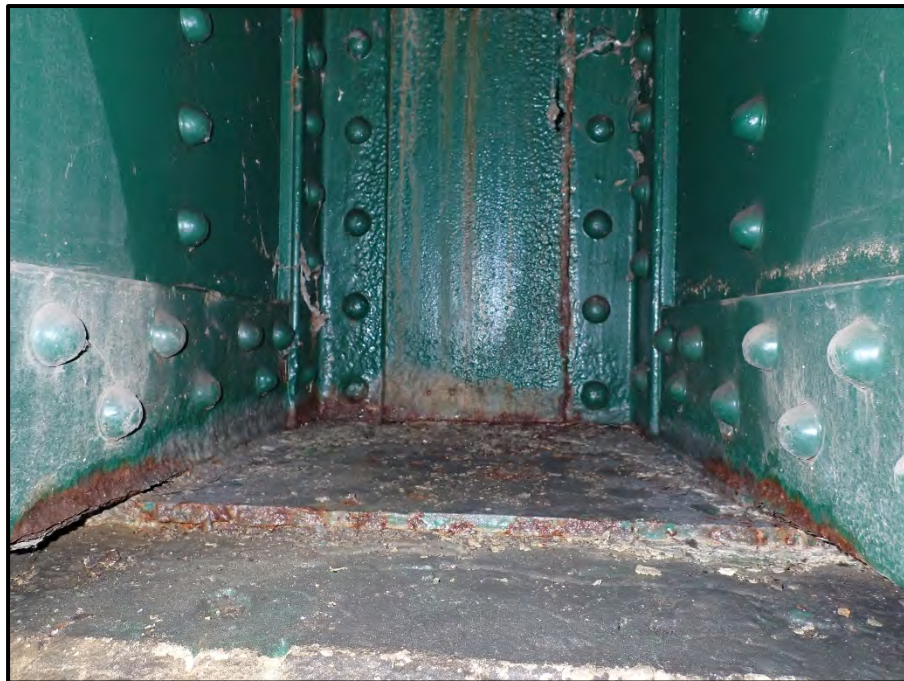
**Photo 10** – Looking east at typical bearing seat condition between beams 3 and 4 and the east abutment. Note: minor surface corrosion, water staining, and active leakage at bearing seat with negligible section loss.

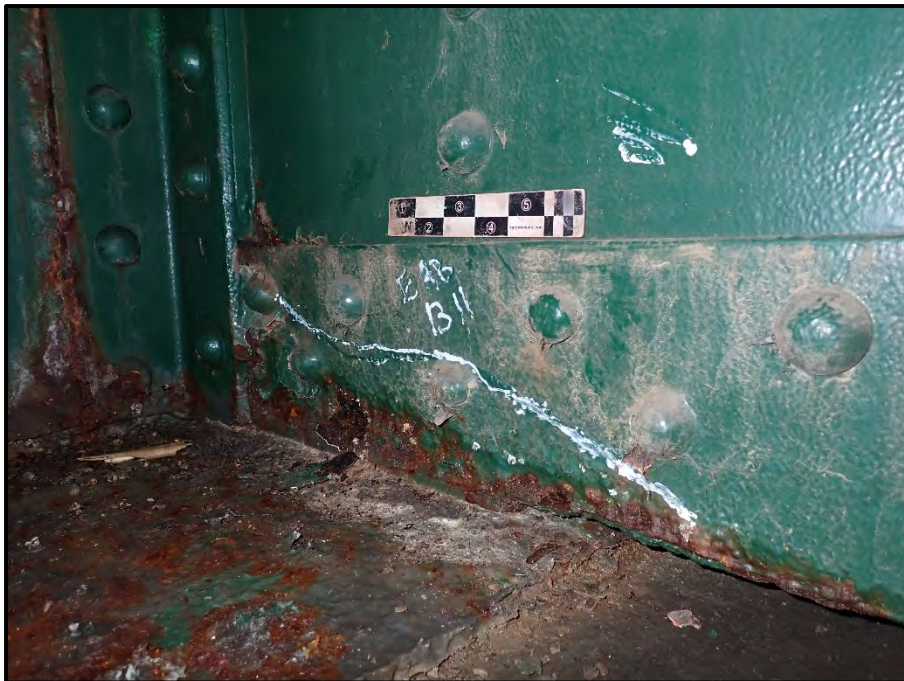
**Photo 12** – Looking east at north web of beam 11 at the east abutment exhibits a 14" long x 4" tall area of up to 1/16" deep painted over section loss in the bottom of the web plate.

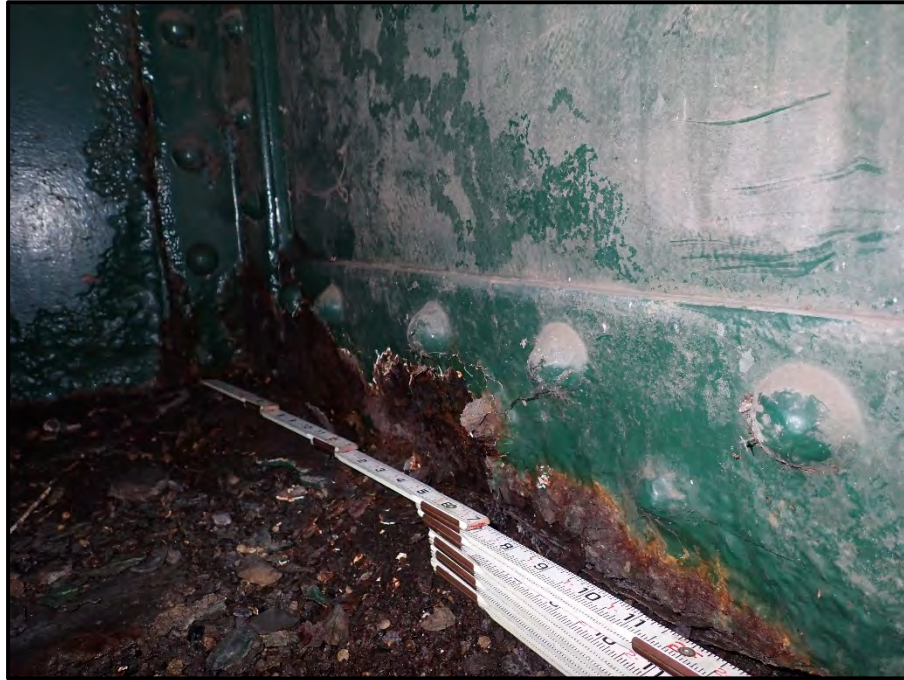
**Photo 13** – Looking east at the north face of beam 13 bottom of web at the east abutment a 15" long x 3" tall area of active corrosion with up to 1/16" deep section loss.

| <b>Photo #</b> | <b>Call Out #</b> | <b>Comment</b> |
|---|---|---|
| Photo 14 | C-LAL-G | North face of beam 13 bottom of web at the east abutment exhibits a 15" long x 3" tall area of active corrosion with up to 1/16" deep section loss. |

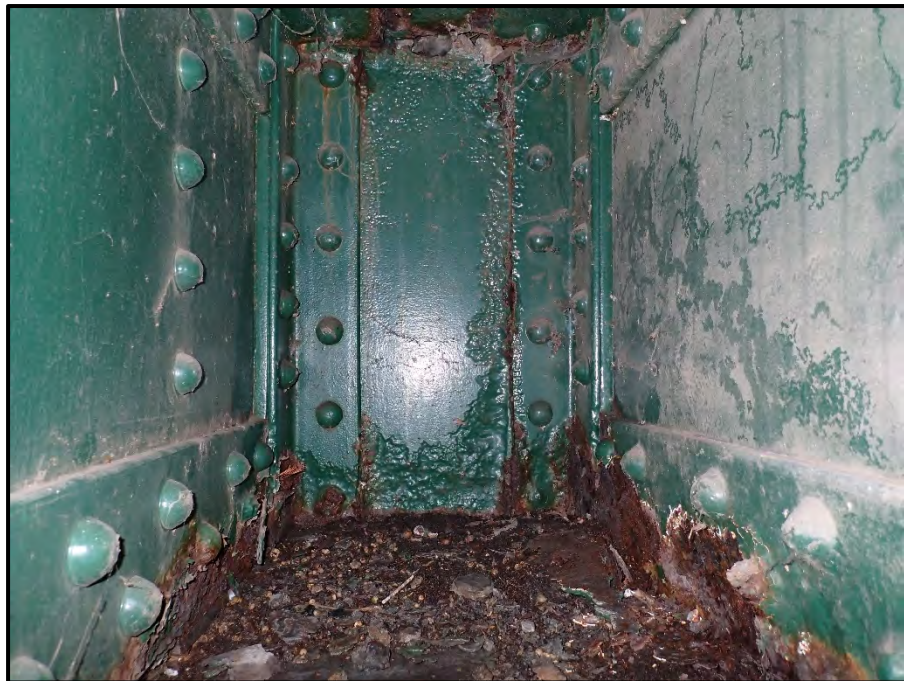
**Photo 14** – Looking east at Overall of the steel backwall between beam 12 and 13 at the east abutment. Note: up to 1/8" painted over section loss throughout with a 4" wide x 1" tall void/corrosion hole in the top of the back and end of deck pan. Ballast is exposed.

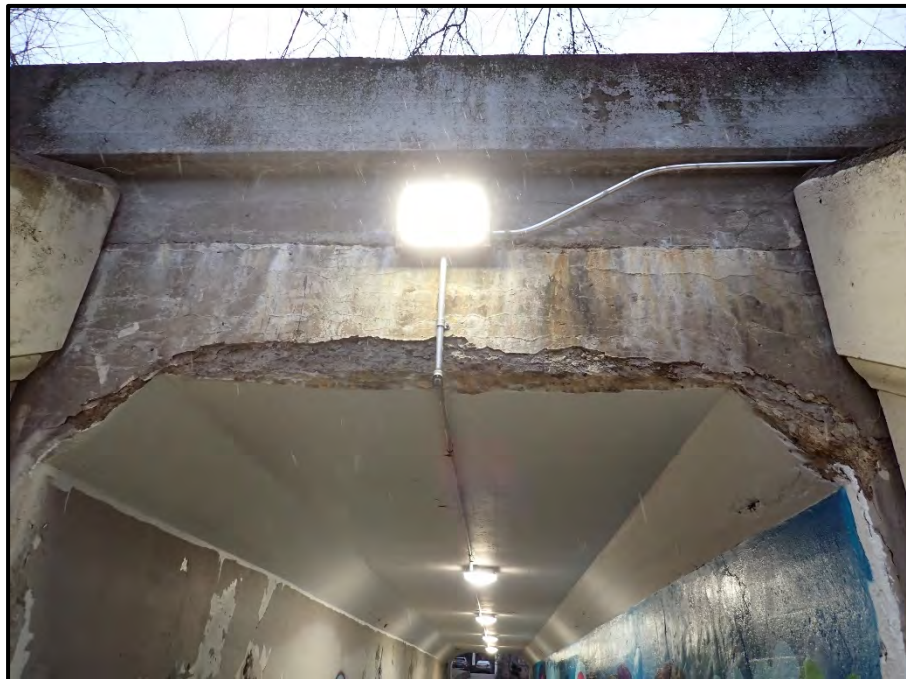
**Photo 6** – Looking north at full width (8') x 6" tall x up to 1" deep spall in the bottom corner of the south end tunnel entrance. 1' tall x 8' wide area of adjacent delamination above spall.
