### Structure Type Studies

Re: Great Parks of Hamilton County – Oasis Corridor  
B&N Bridge Assessment – Collins Ave

April 2, 2026

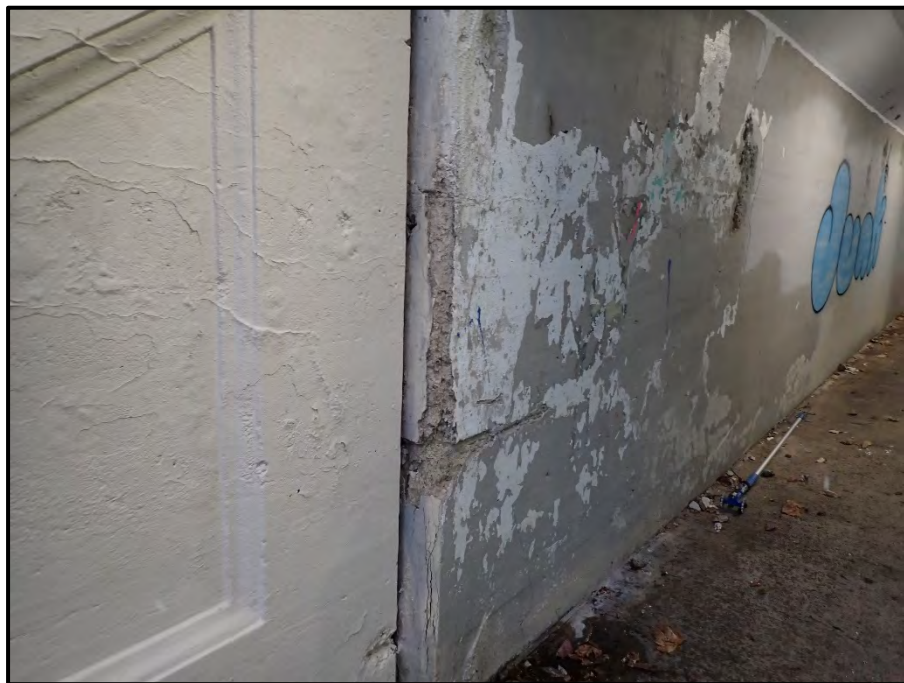
**Photo 8** – Looking northwest at 3' x 6' x 2" deep spall in the south end of the east wall at the south entrance.

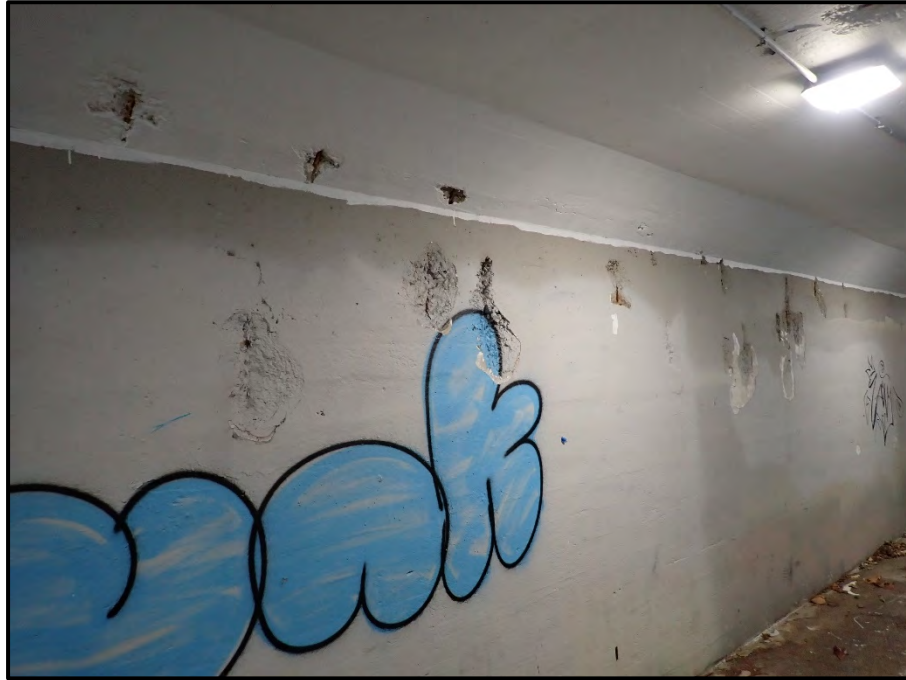
**Photo 9** – Looking northwest at 30 SF of intermittent spalling on the west wall, up to 1" deep.

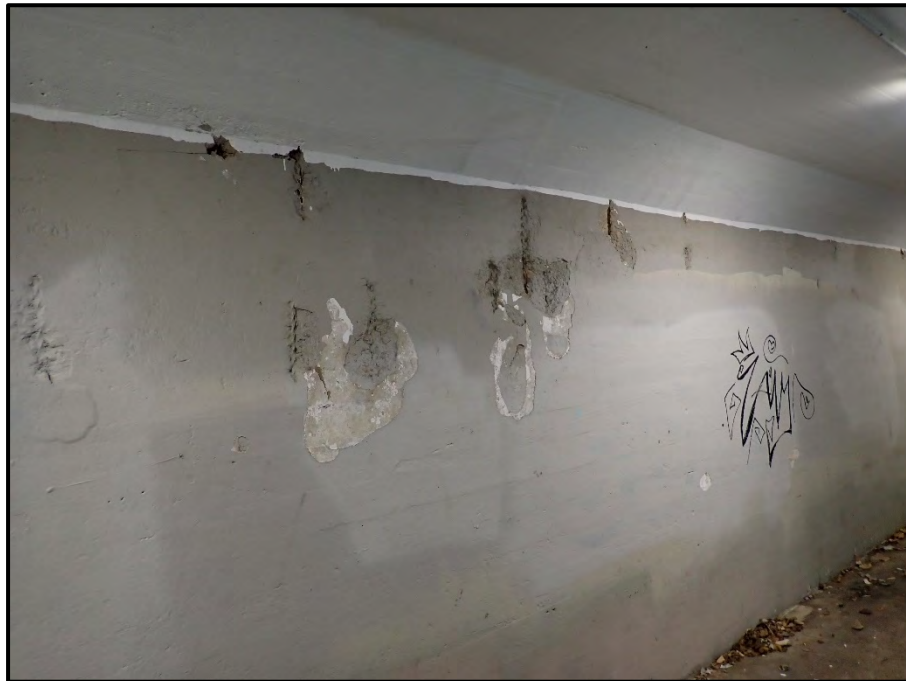
**Photo 10** – Looking northwest at 30 SF of intermittent spalling on the west wall, up to 1" deep.

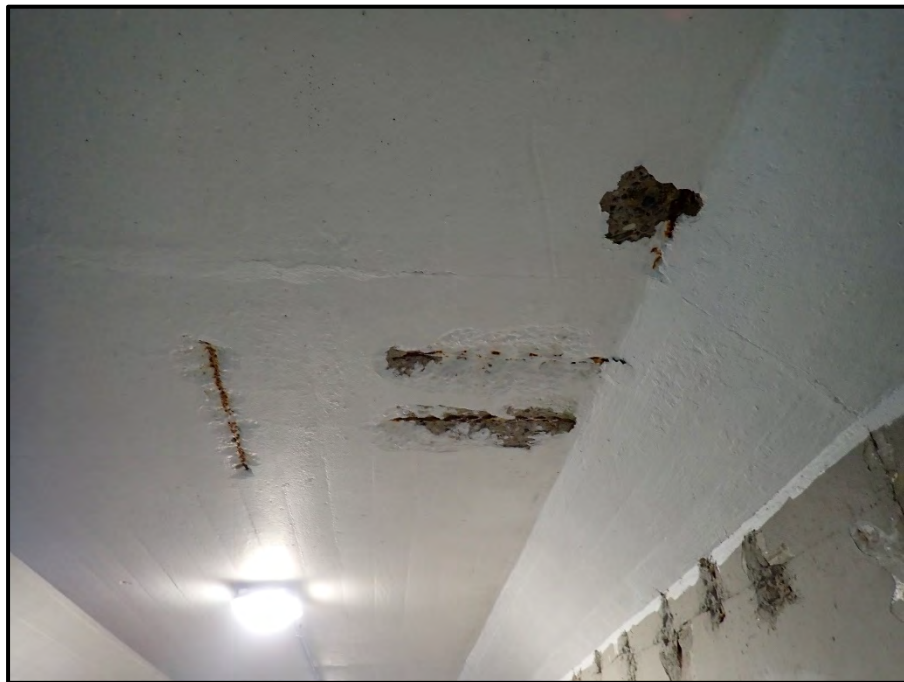
**Photo 12** – Looking south at 4 SF of spalling on the underside of top slab 8' from the north end with exposed and corroding rebar.

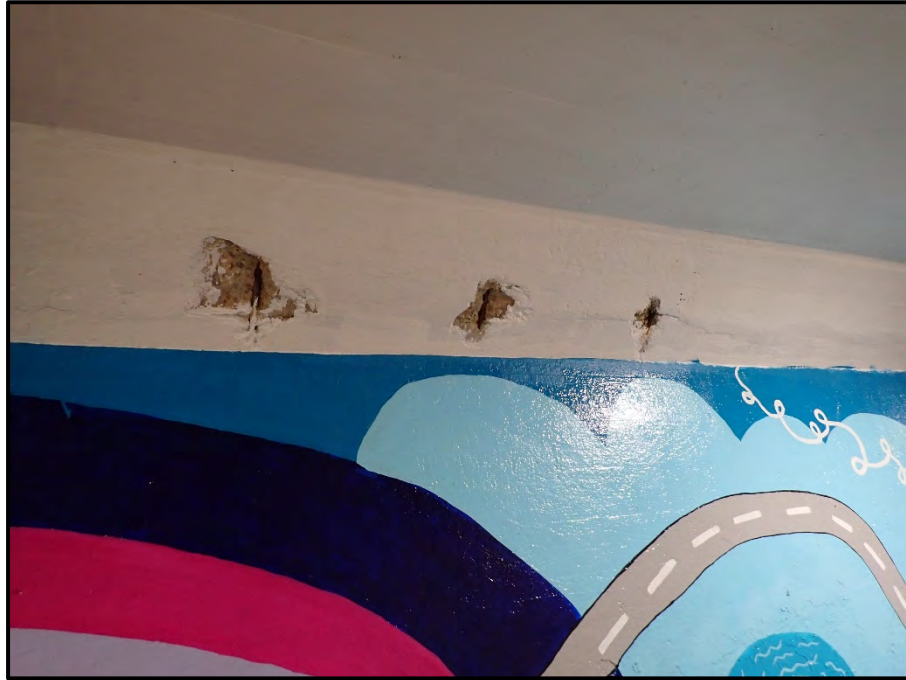
**Photo 13** – Looking east at three, 1 SF spalls in the east top slab chamfer 15' from the north end with exposed and corroding rebar.

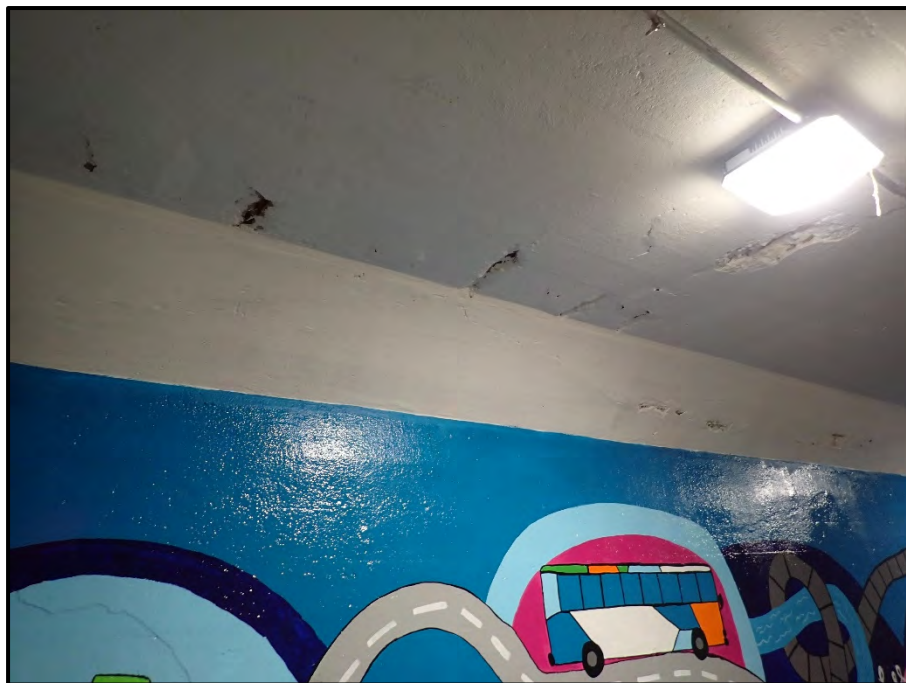
**Photo 14** – Looking southeast at 4 SF of spalls with exposed rebar 20' from the south end.

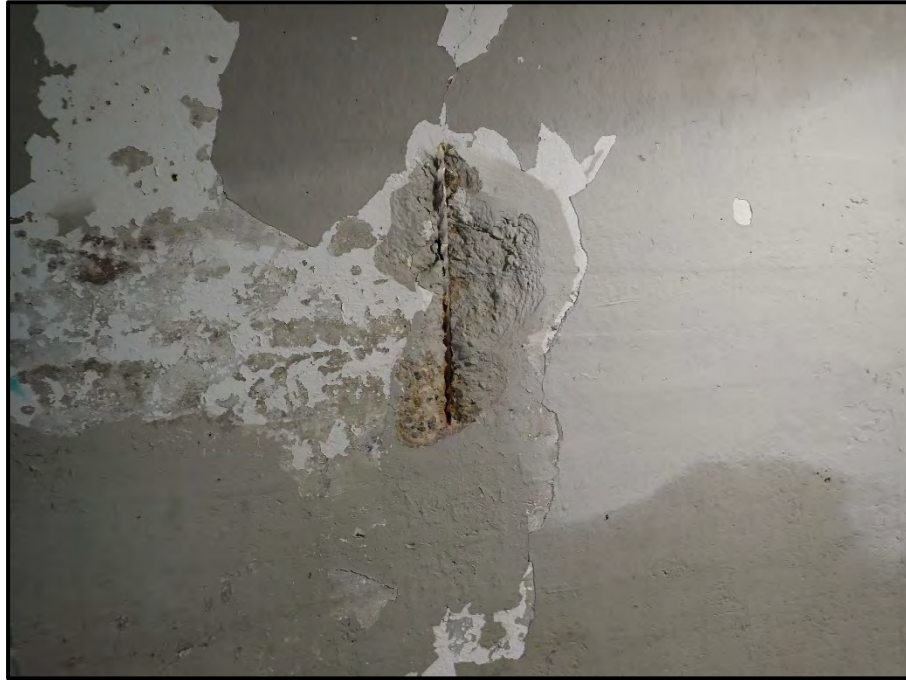
**Photo 15** – Looking west at 2' x 1' x 1" deep spall with one exposed and corroding spiral bar on the west wall, 8' from the south end.

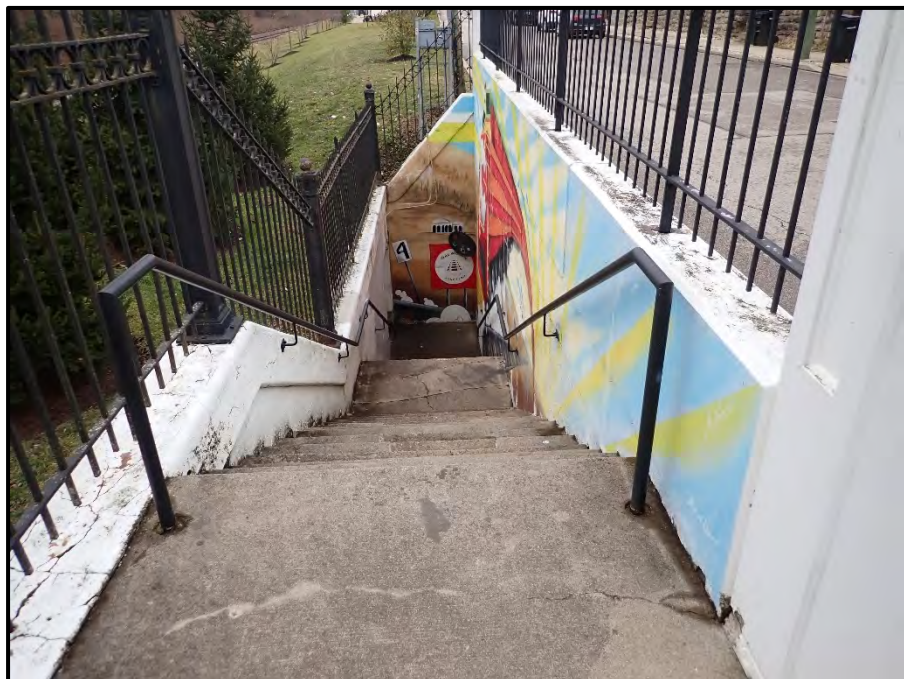
**Photo 8** – Looking west down the north end steps. Note: minor isolated crack in the concrete steps. Flaking seal coat and insignificant width isolated cracks in retaining walls.

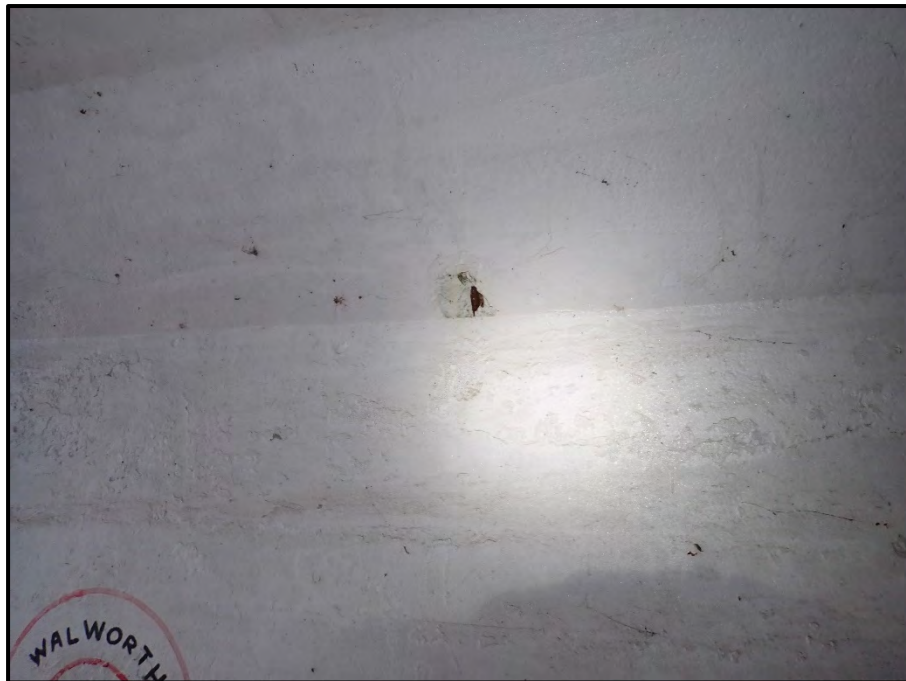
**Photo 12** – Looking west at 4" diameter x 1/2" deep spall 10' from the south end of the tunnel.

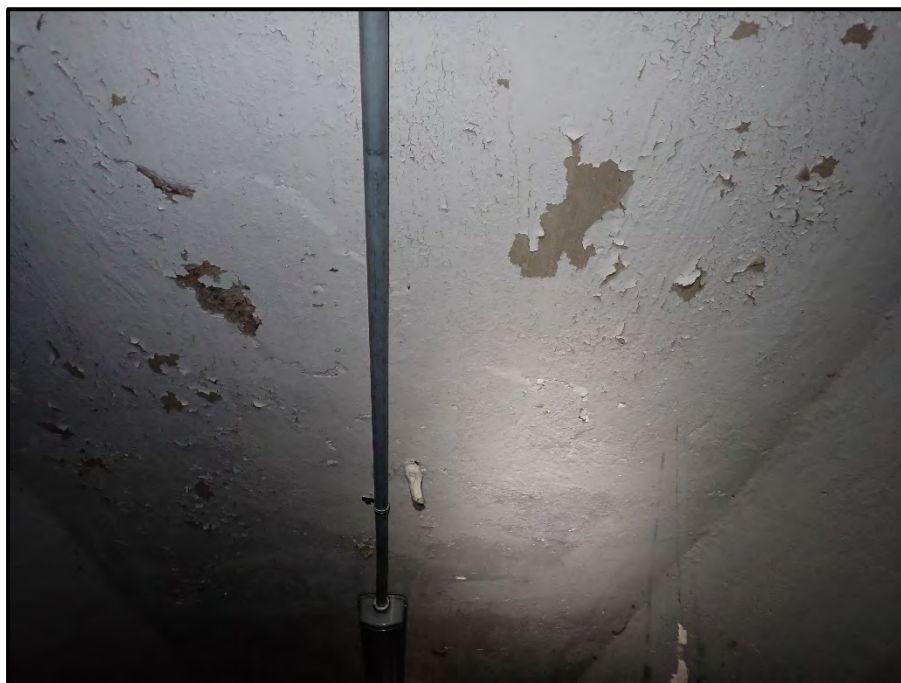
**Photo 13** – Looking north at 2 SF of delaminations, 52' from the north end of the tunnel.
