### Structure Type Studies

Re: Great Parks of Hamilton County – Oasis Corridor  
B&N Bridge Assessment – Collins Ave

April 2, 2026

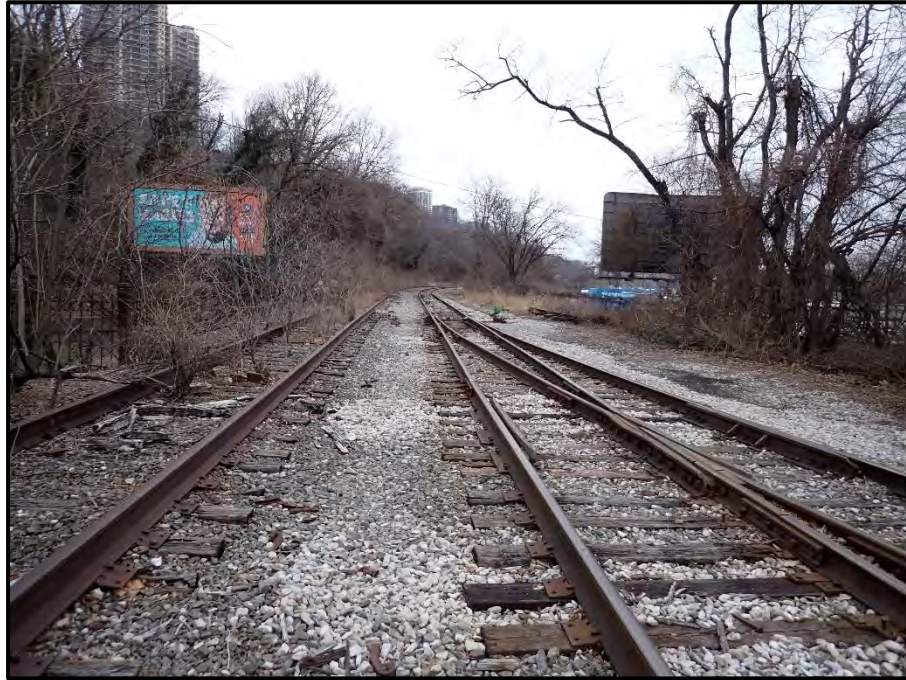
**Photo 3** – End view looking east.

There is no deck on this structure. The steel deck pans hold up the fill and ballast under the rails (**photos 3 & 4**).

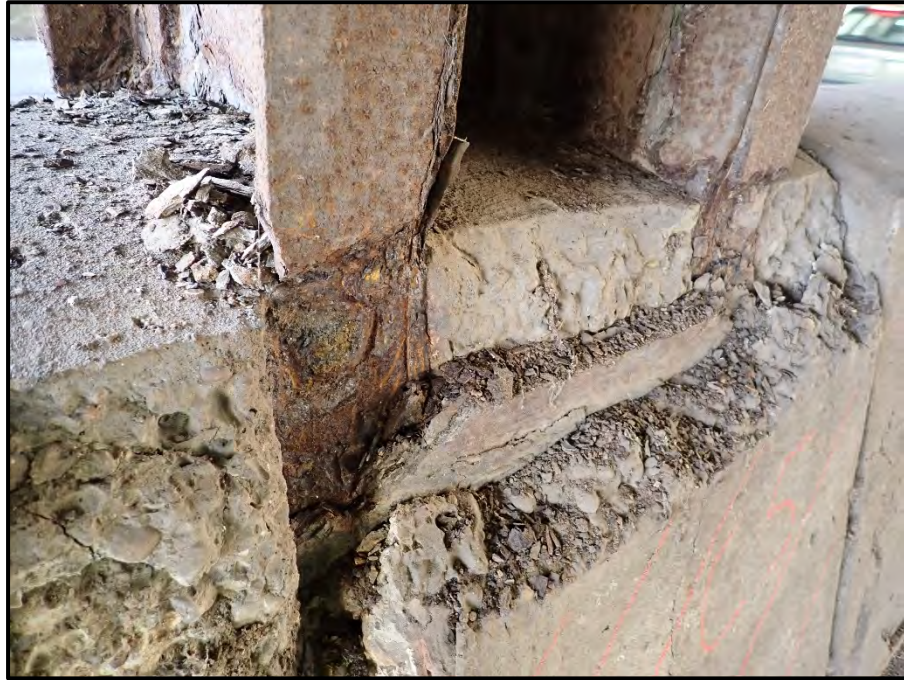
**Photo 9** – Looking west at an overall of the east face vertical angle legs at the pier wall exhibit up to 75% section loss to angle legs over a 1" tall x full width area.

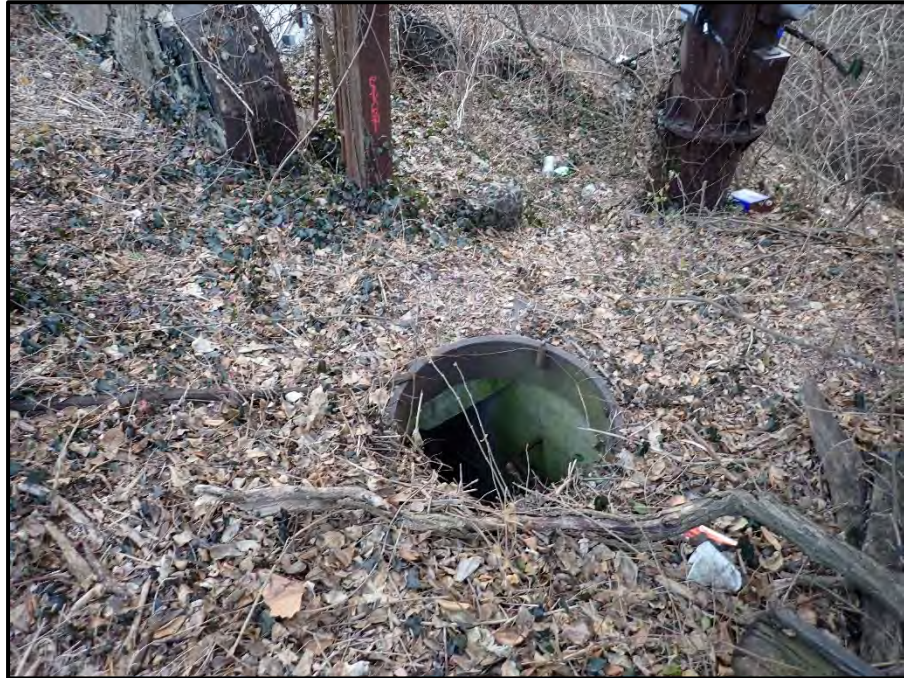
**Photo 13** – Looking south at the open manhole at the southwest approach.

- Proceed with rehabilitation plans developed for SORTA in 2024.
- Replace the missing manhole cover at the northwest approach
- Remove debris from girder abutment bearing seats at all four corners.
- Abrasively clean, paint, and remove pack rust between bearing seat and underside of the girders at abutments.
- The City of Cincinnati has requested a load rating of the bridge since the structure will carry railroad loads and there is not documentation on the load carrying capacity of the bridge.

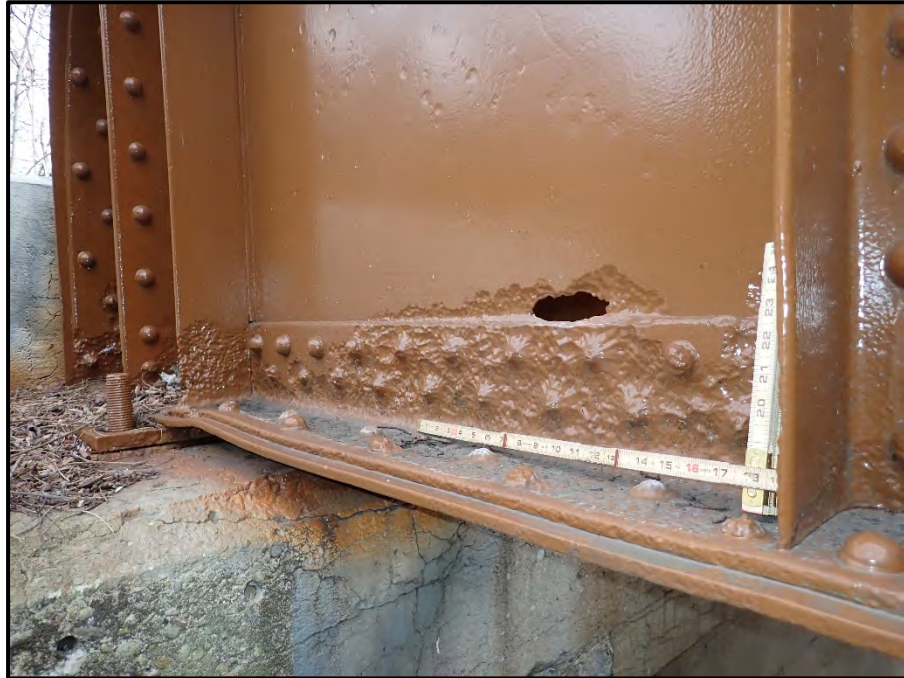
| Girder | Bridge Location | Corrosion hole dimension | Photos |
|---|---|---|---|
| Girder 1 | East end girder web between 2 <sup>nd</sup> and 3 <sup>rd</sup> stiffeners from east abutment. | 4 ½" x 1 ½" | Photos 9 & 10 |

**Photo 9** – Looking southeast at the outboard face of girder 1 at east end between the 2nd and 3rd stiffeners from east. Note: 4 1/2 inch x 1 1/2-inch and 2 1/2 inches x 1 1/2 inch through hole in web plate with adjacent pitting down to knife edge.

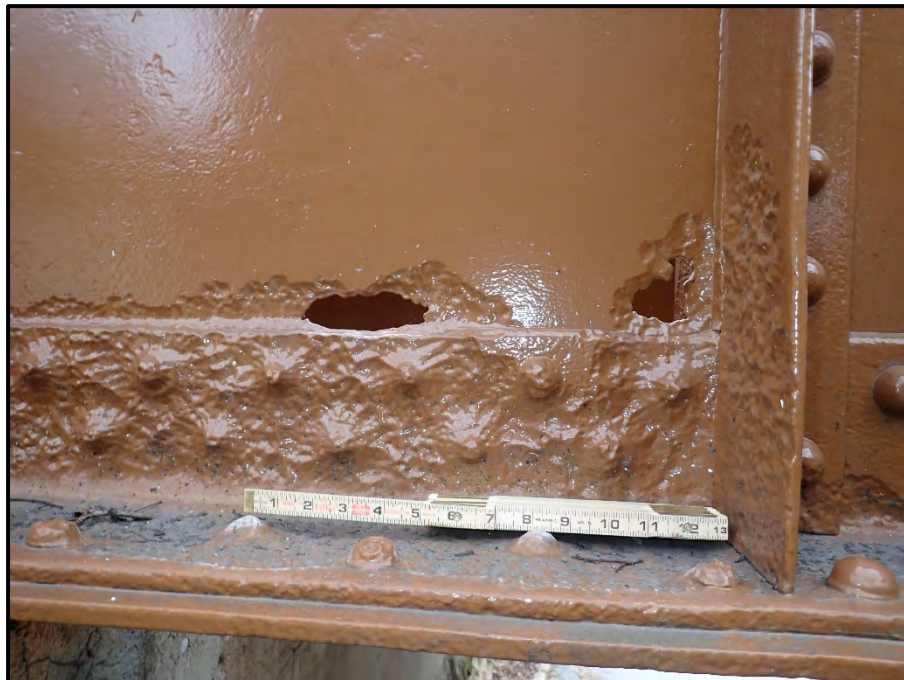
| Girder | Bridge Location | Corrosion hole dimension | Photos |
|---|---|---|---|
| Girder 1 | East end girder web between 2 <sup>nd</sup> and 3 <sup>rd</sup> stiffeners from east abutment. | 2 ½" x 1 ½" | Photo 10 |

**Photo 10** – Looking southeast at the outboard face of girder 1 at east end between the 2nd and 3rd stiffeners from east. Note: 4 1/2" x 1 1/2" and 2 1/2" x 1 1/2" through hole in web plate with adjacent pitting down to knife edge.

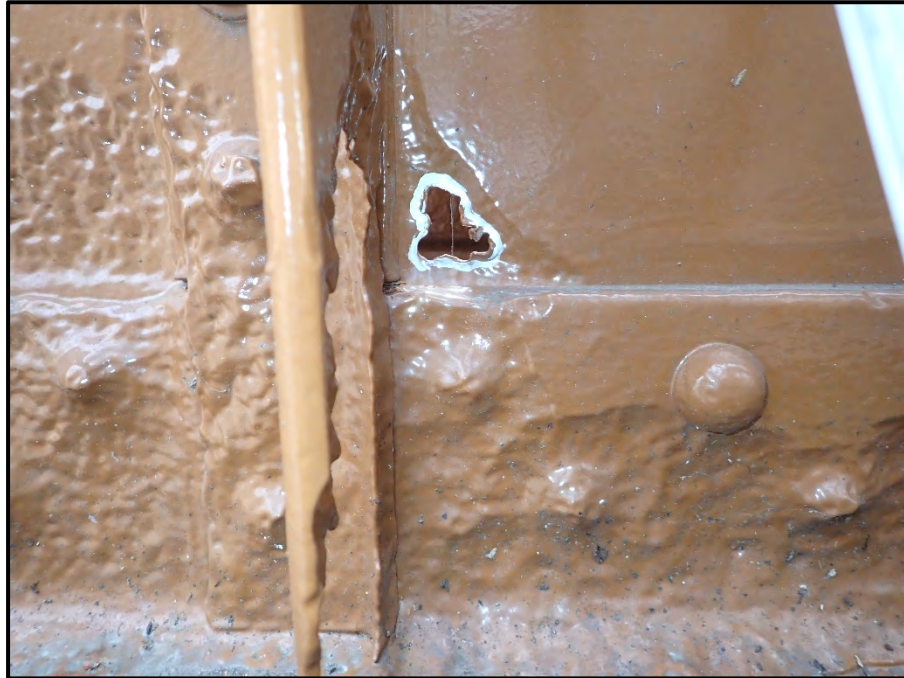
| Girder | Bridge Location | Corrosion hole dimension | Photos |
|---|---|---|---|
| Girder 1 | West end girder web adjacent to the 3 <sup>rd</sup> stiffener from west end. | 1 ¼" diameter | Photo 13 |

**Photo 13** – Looking south at outboard face of girder 1 adjacent to 3rd stiffener from end. Note: 1 1/4" painted over corrosion hole on web.

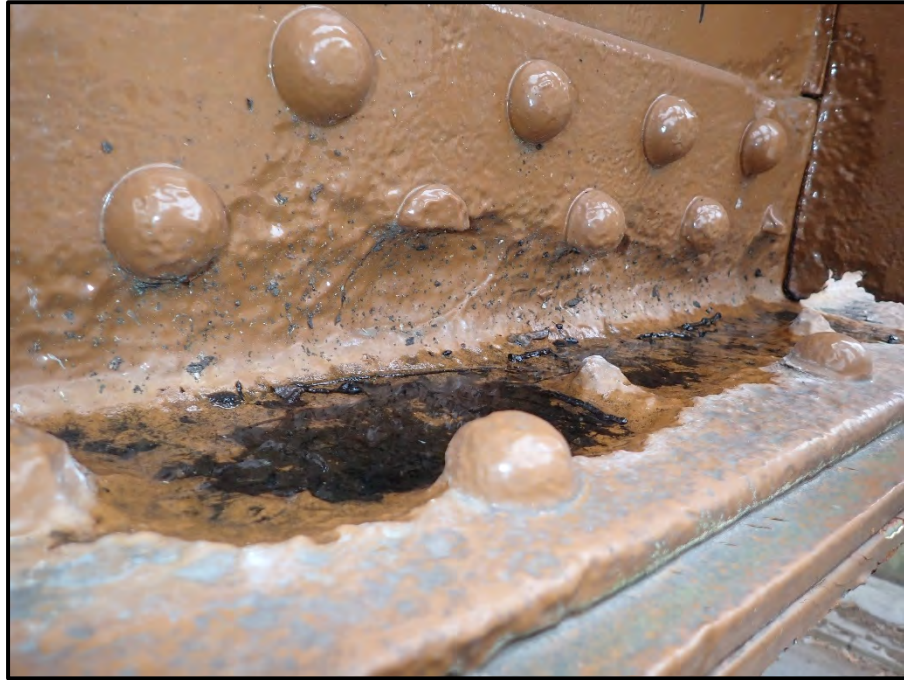
**Photo 15** – Looking southeast at the outboard face of girder 1 bottom flange angle at east half of girder. Note: 1/8" average, 3/8" max painted over pitting along bottom flange angle. All bottom flange angle rivets exhibit painted over section loss, half of which are 50% or greater.

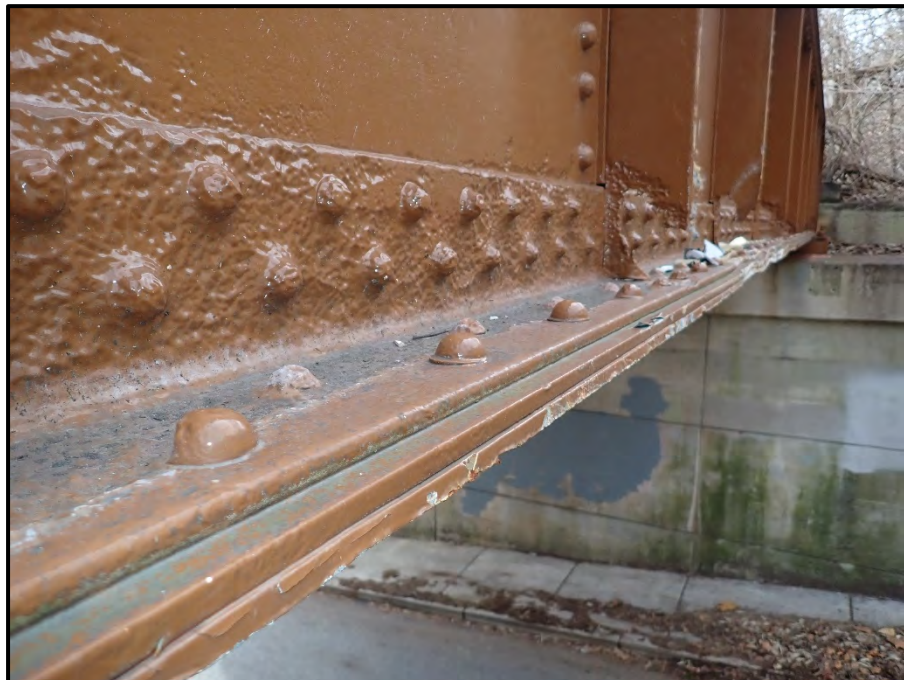
**Photo 16** – Looking southwest at the outboard face of girder 1 bottom flange angle at east half of girder. Note: 1/8" average, 3/8" max painted over pitting along bottom flange angle. All bottom flange angle rivets exhibit painted over section loss, half of which are 50% or greater.

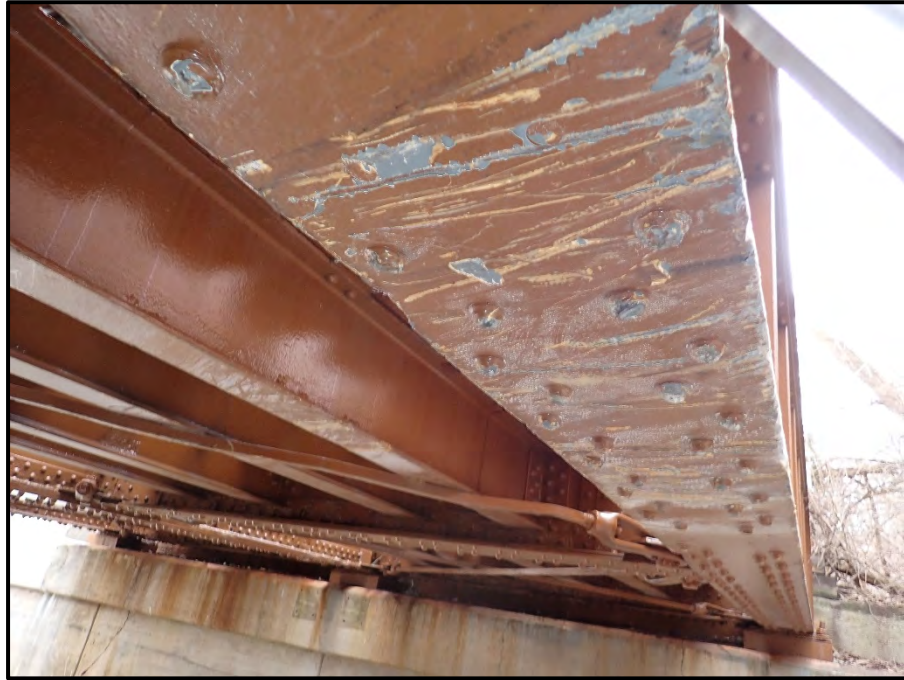
**Photo 17** – Looking west at the bottom flange of girder near mid-span. Note: Multiple impact scrapes and gouges along bottom flange plates. Minor deformation of bottom flange.

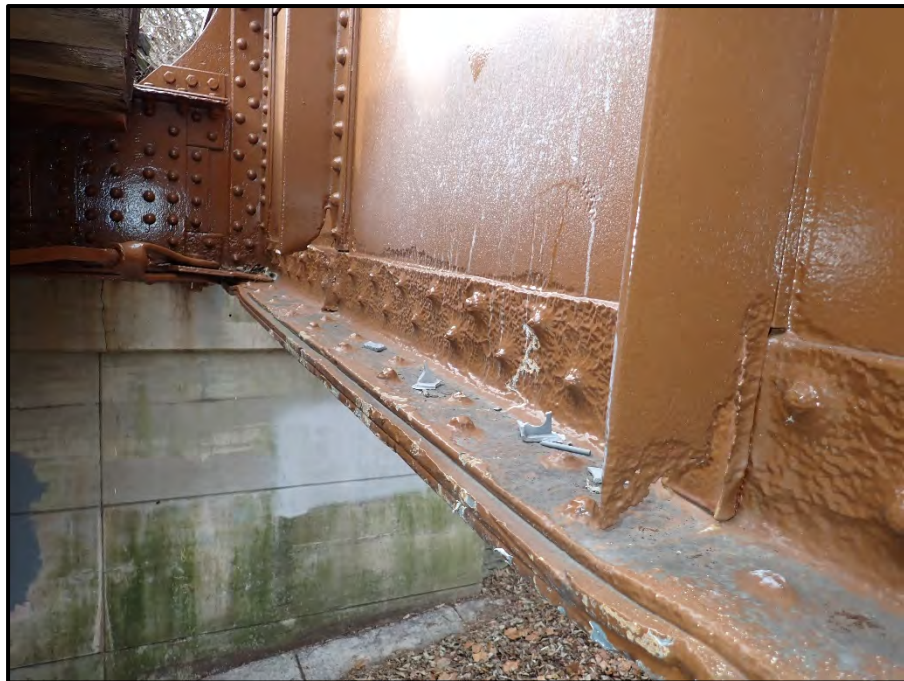
**Photo 18** – Looking northwest at the inboard face of girder 1. Note: Inboard face of girder 1 bottom flange angle. 1/8" average, 3/8" max painted over pitting along bottom flange angle. All bottom flange angle rivets exhibit painted over section loss, half of which are 50% or greater.

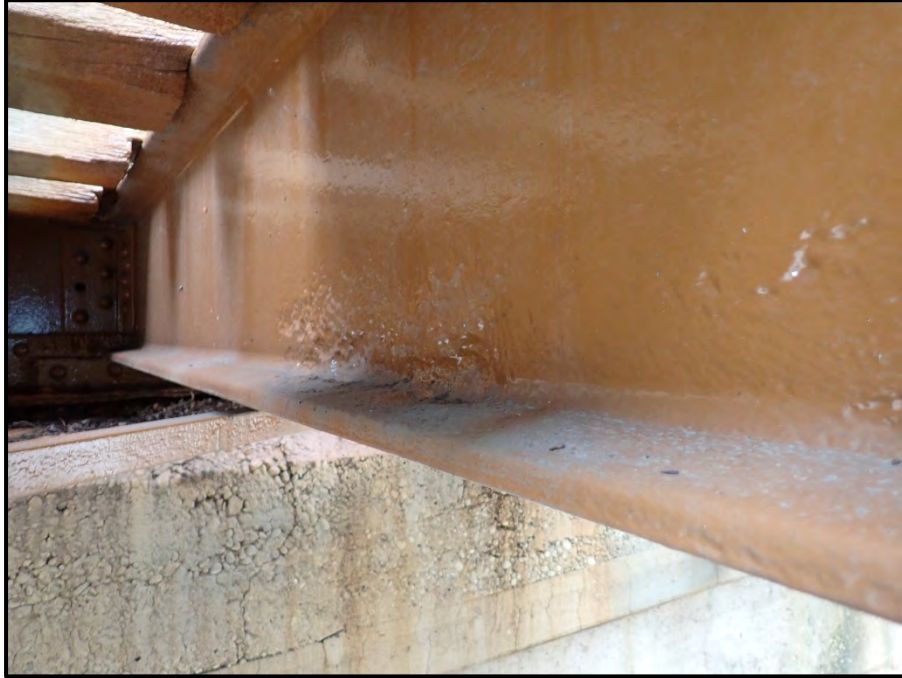
**Photo 19** – Looking southwest at stringer 3 in floor beam bay 2-3. Note: Widespread 1/16" deep painted over pitting along bottom 4" of web.

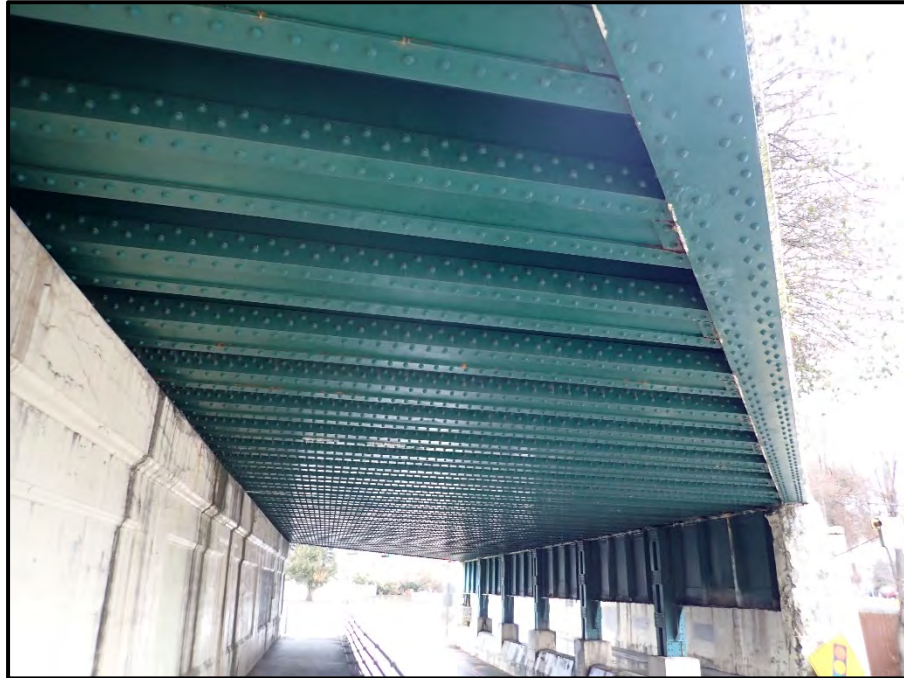
**Photo 5** – Looking south at the general underside condition of span 2.

There is no deck on this structure. The steel deck pans hold up the fill and ballast under the rails **(photo 5)**.

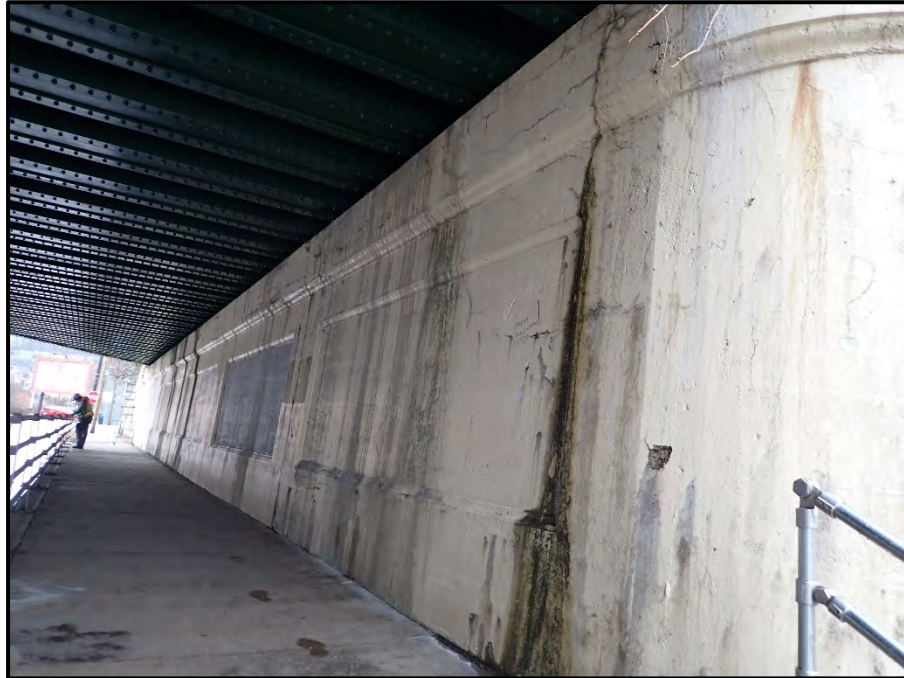
**Photo 7** – Looking northeast at overall elevation of the east abutment from south end. Note: isolated delaminations totally less than 20 SF. Horizontal and vertical moderate width cracking throughout abutment cap. Concreted is generally sound around cracks.

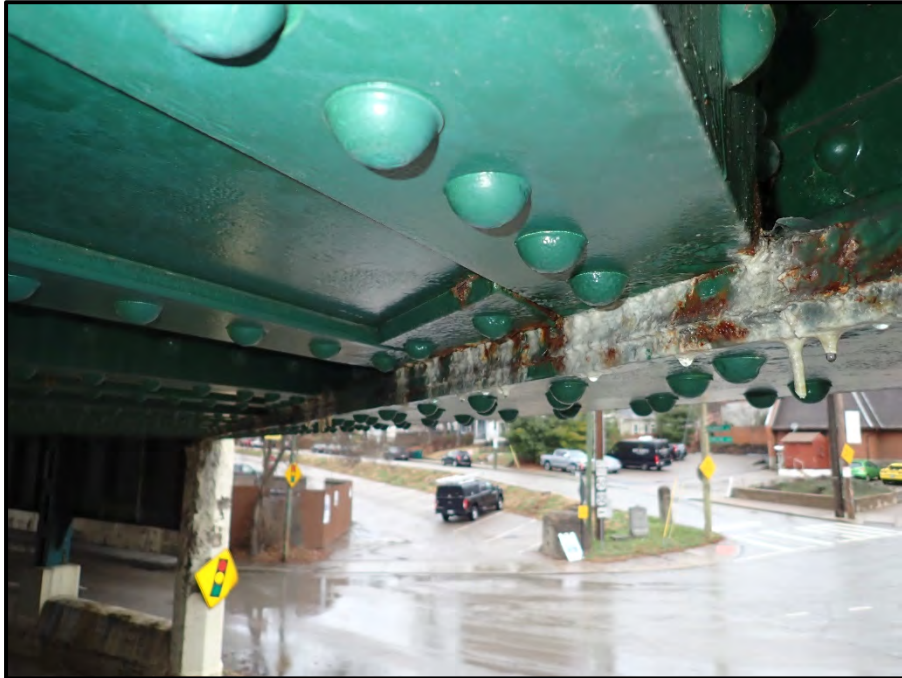
**Photo 9** – Looking northwest at the typical efflorescence and water staining on the bottom flange of beam 3 at the north girder in span 2.

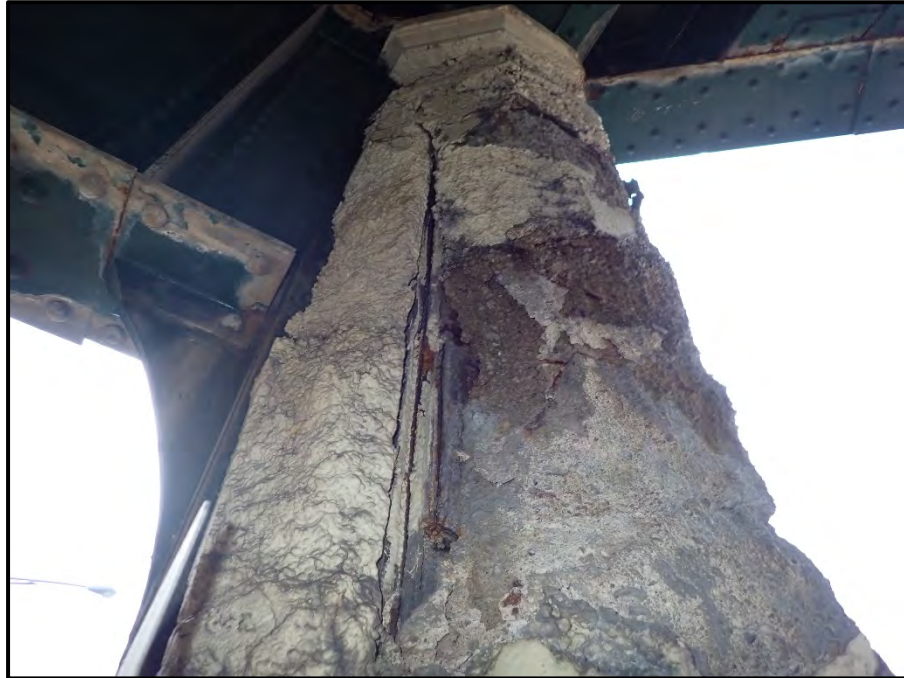
**Pier 1 - Column 7** - concrete is in poor condition and appears to not contain any reinforcement and only appears to protect the underlying built up steel column. A small portion of the steel column is exposed and is in poor condition and exhibit section loss and pack rust between components up to 1/2". Full condition of steel column is unable to be determined due to encasement. Concrete is unsound throughout including portion of exposed core concrete **(photos 13-15)**. Column 1 is in similar condition **(photo 16)**.

**Photo 13** – Looking east at overall of column 7. Note: concrete is in poor condition and appears to not contain any reinforcement and only appears to protect the underlying built up steel column. A small portion of the steel column is exposed and is in poor condition and exhibit section loss and pack rust between components up to 1/2".

- Abrasively clean and spot paint areas of surface corrosion to steel superstructure and pier.
- Periodically inspect for loose concrete on abutment walls and pier protection. Remove any loose concrete that may pose a safety hazard to pedestrians and vehicular traffic.
- Monitor pier 1 column 7 for further spalling and steel section loss. Consider patching or replacing concrete encasement at this column.
- The City of Cincinnati has requested a load rating of the bridge since the structure will carry railroad loads and there is not documentation on the load carrying capacity of the bridge.

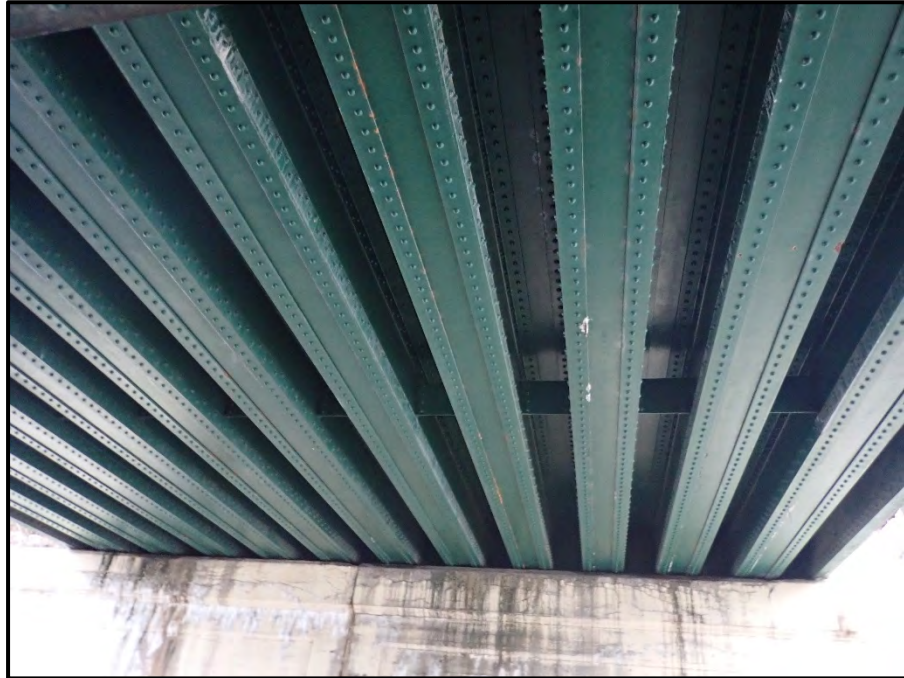
**Photo 5** – Looking west at the underside of span 1. Note: isolated locations of surface corrosion with minor section loss.

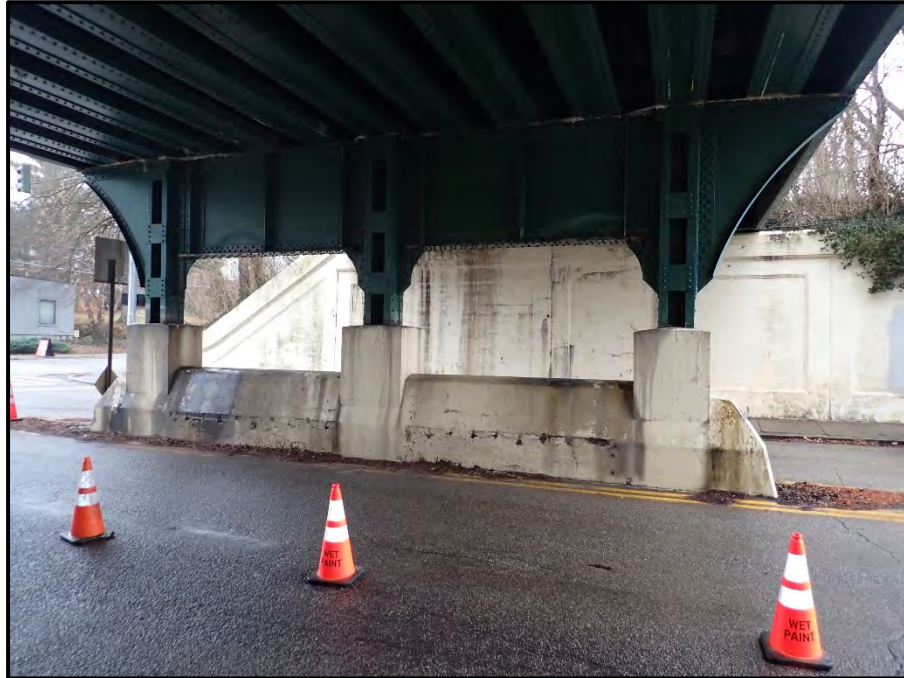
**Photo 7** – Looking west at the overall of the west face of pier 1.

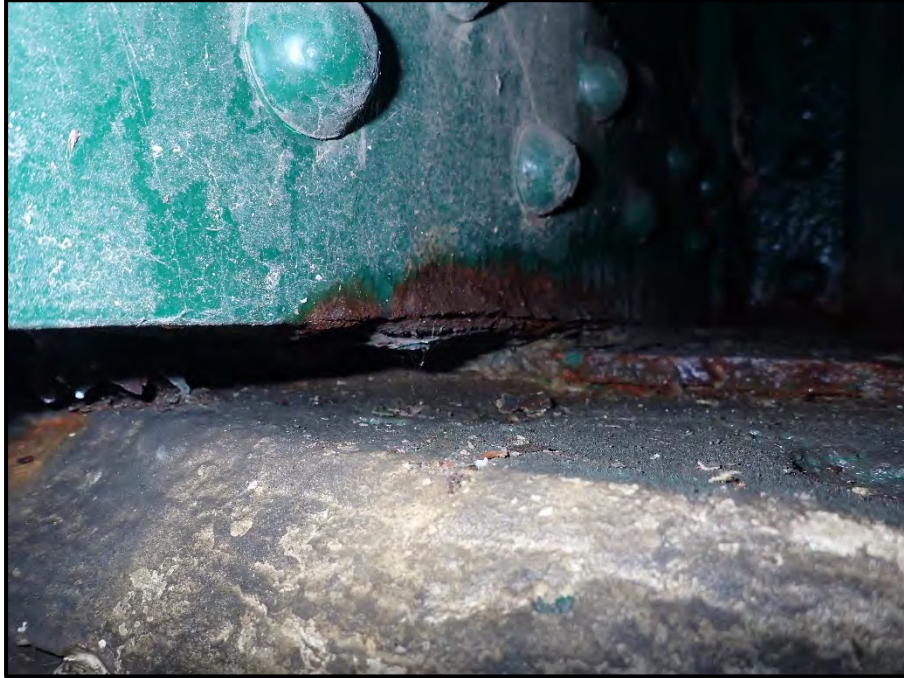
**Photo 11** – Looking east at underside of beam 3 at the east abutment. Note: minor surface corrosion and water staining on the bottom of beam with negligible section loss.

| <b>Photo #</b> | <b>Call Out #</b> | <b>Comment</b> |
|---|---|---|
| Photo 11 | C-LAL-D | Underside of beam 3 at the east abutment. Note: minor surface corrosion and water staining on the bottom of beam with negligible section loss. |

- Consider spot cleaning and painting isolated locations of surface corrosion to beam ends.
- Add a plate or angle to the top of the steel backwall between beams 12 and 13 at the east abutment to prevent loss of ballast.
- The City of Cincinnati has requested a load rating of the bridge since the structure will carry railroad loads and there is not documentation on the load carrying capacity of the bridge.

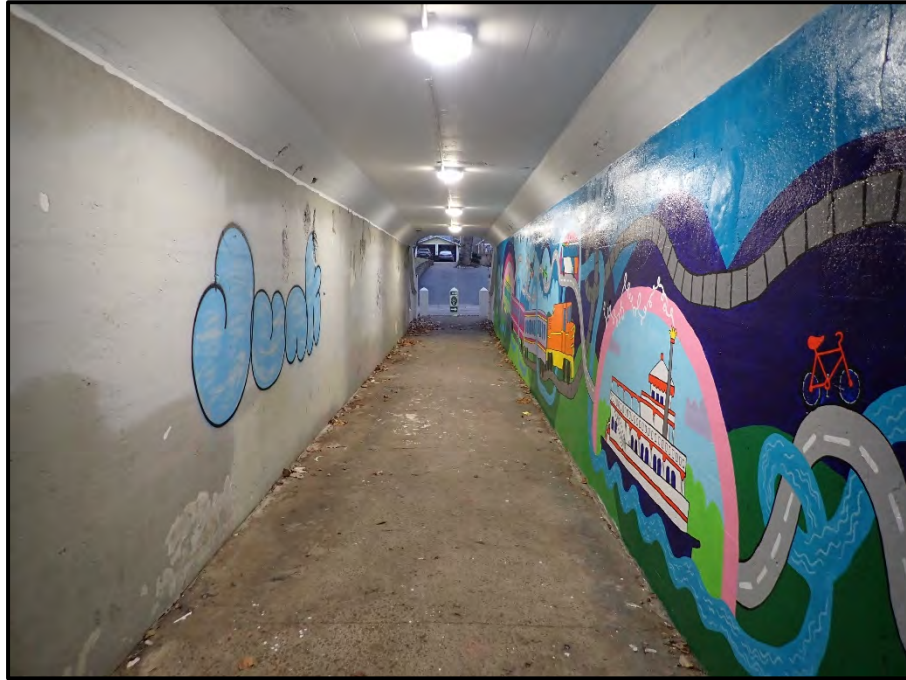
**Photo 5** – Looking south at the typical inside of tunnel condition.

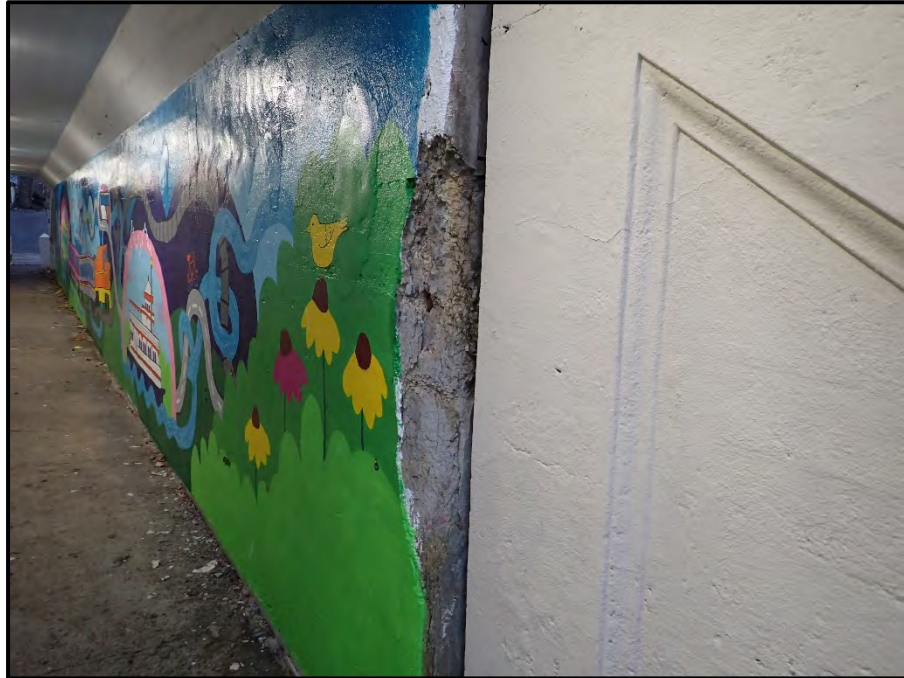
**Photo 7** – Looking north at 9' x 1' x 3" deep spall in the east end of the east wall at the south entrance.

| <b>Photo #</b> | <b>Call Out #</b> | <b>Comment</b> |
|---|---|---|
| <b>Photo 7</b> | LAL-B | 9' x 1' x 3" deep spall in the east end of the east wall at the south entrance. |

- Abrasively clean and paint areas of spalling with exposed rebar. Consider patching spalls and delaminations with trowelable mortar or concrete based on spall depth.
- Periodically inspect the tunnel for areas of new spalls and delaminations. Remove areas of loose concrete which pose a safety hazard to pedestrians.

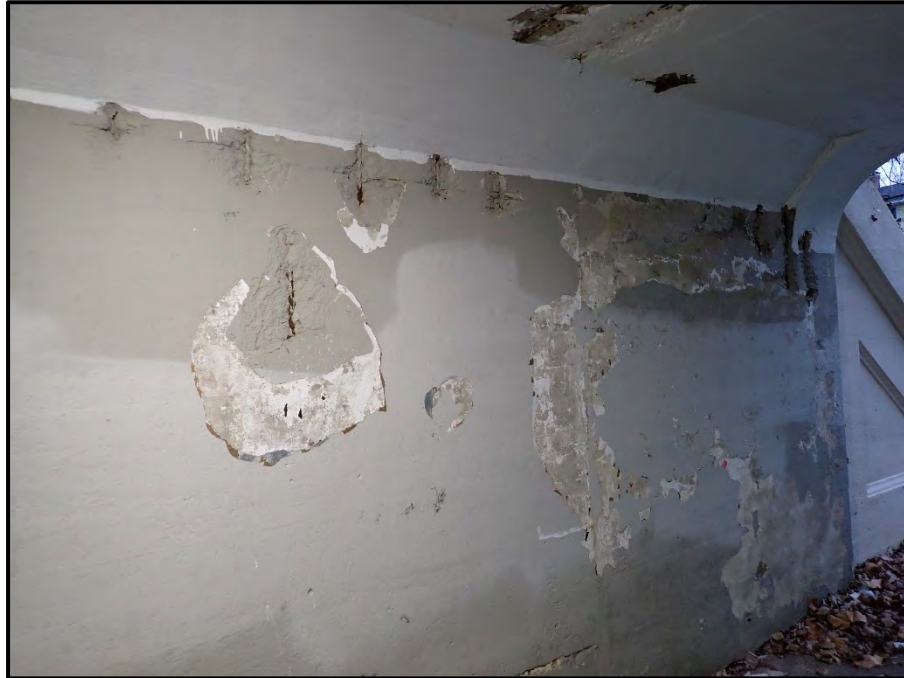
**Photo 11** – Looking northwest at 30 SF of intermittent spalling on the west wall, up to 1" deep.

| <b>Photo #</b> | <b>Call Out #</b> | <b>Comment</b> |
|---|---|---|
| <b>Photo 11</b> | LAL-E | 30 SF of intermittent spalling on the west wall, up to 1" deep. |

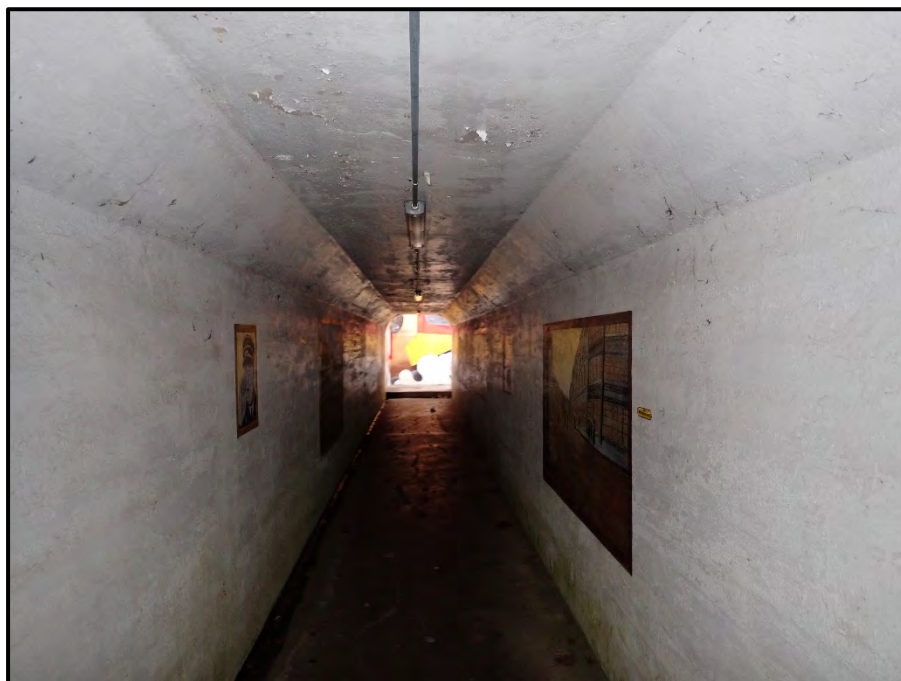
**Photo 5** – Looking north at the typical inside of tunnel condition.

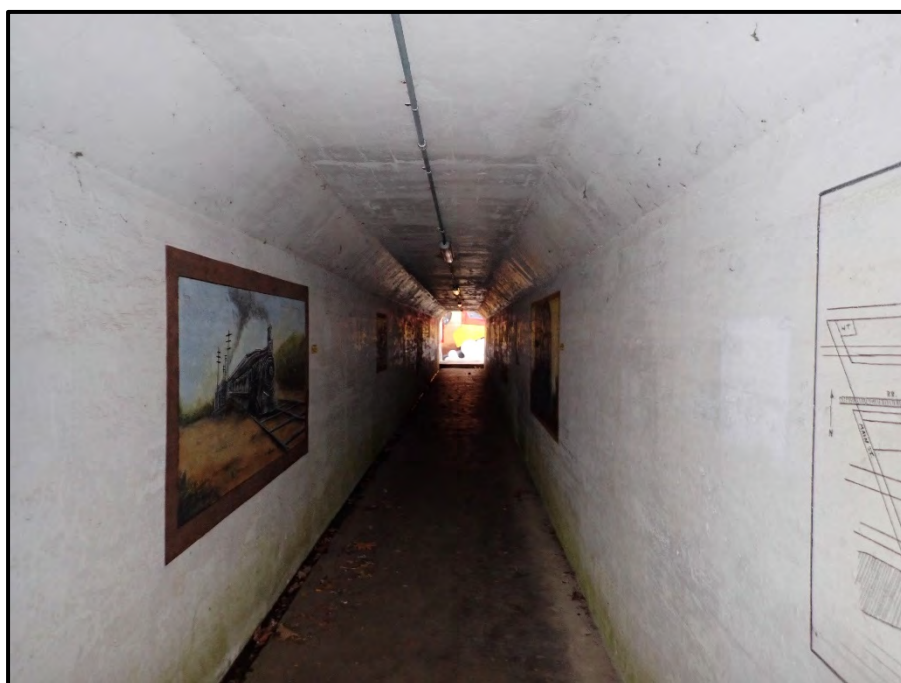
**Photo 6** – Looking north at the typical inside of tunnel condition.

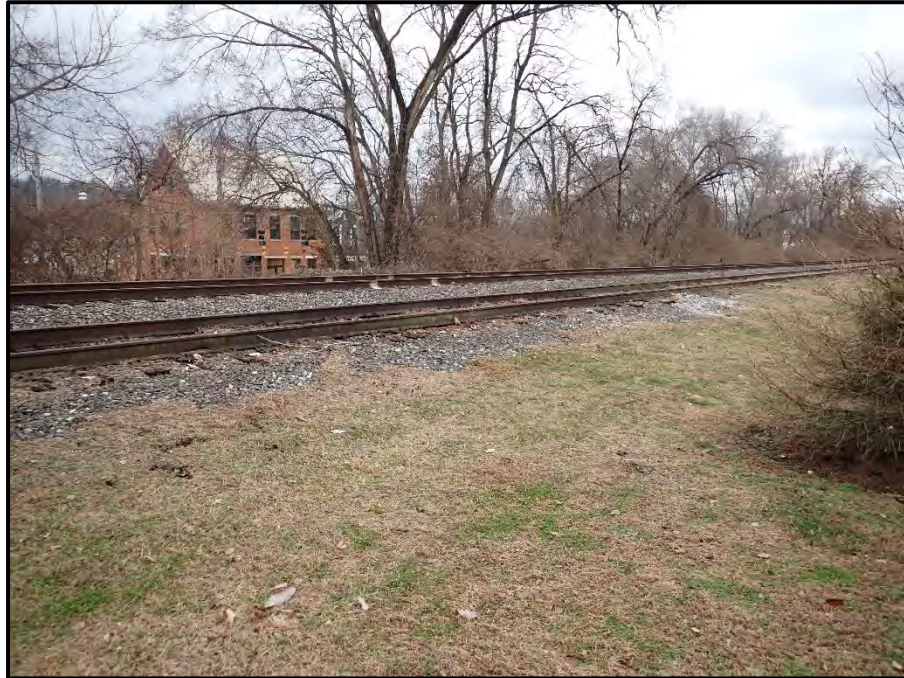
**Photo 7** – Looking southwest at the typical top of track over tunnel condition.

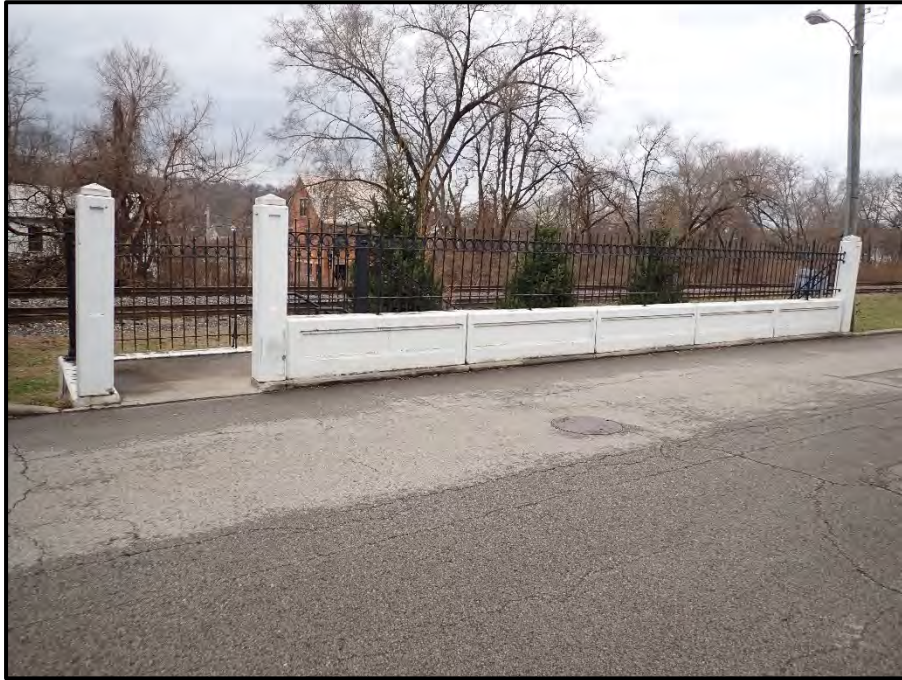
**Photo 9** – Looking south at the overall of the above ground portion of the retaining wall from Walworth Ave.

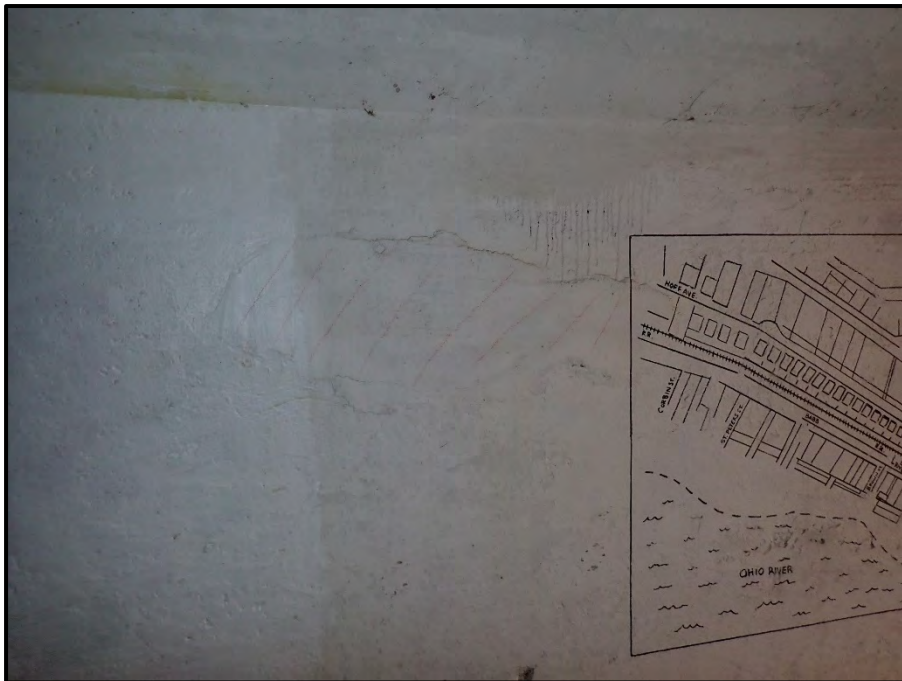
**Photo 10** – Looking west at 3' x 1' unsound patch on the west wall 5' from the north end of the tunnel.

| <b>Photo #</b> | <b>Call Out #</b> | <b>Comment</b> |
|---|---|---|
| <b>Photo 10</b> | LAL-A | 3' x 1' unsound patch on the west wall 5' from the north end of the tunnel. |

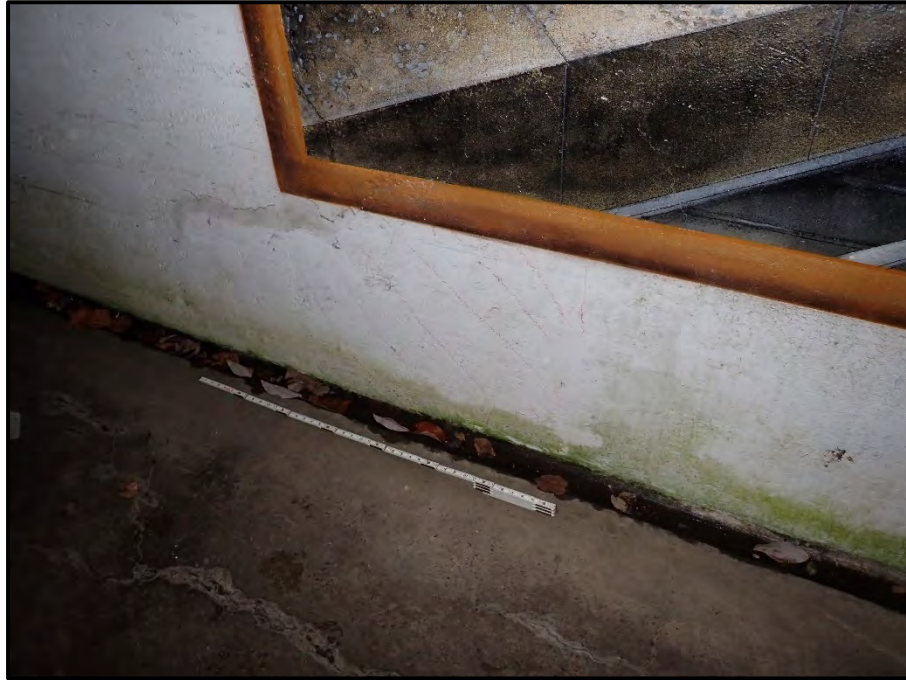
**Photo 11** – Looking west at 3.5' x 1' delamination on the west wall 10' from the north end of the tunnel.

| <b>Photo #</b> | <b>Call Out #</b> | <b>Comment</b> |
|---|---|---|
| <b>Photo 11</b> | LAL-B | 3.5' x 1' delamination on the west wall 10' from the north end of the tunnel. |
